Re: Housatonic NRD Potential Project  
Removal of Pin Shop Pond Dam  
Oakville, CT

Housatonic NRD Potential Project  
Removal of Pin Shop Pond Dam  
Oakville, CT

THE OLD PIN SHOP, LLC.  
 PIN SHOP POND DAM  
 WATERTOWN, CONNECTICUT

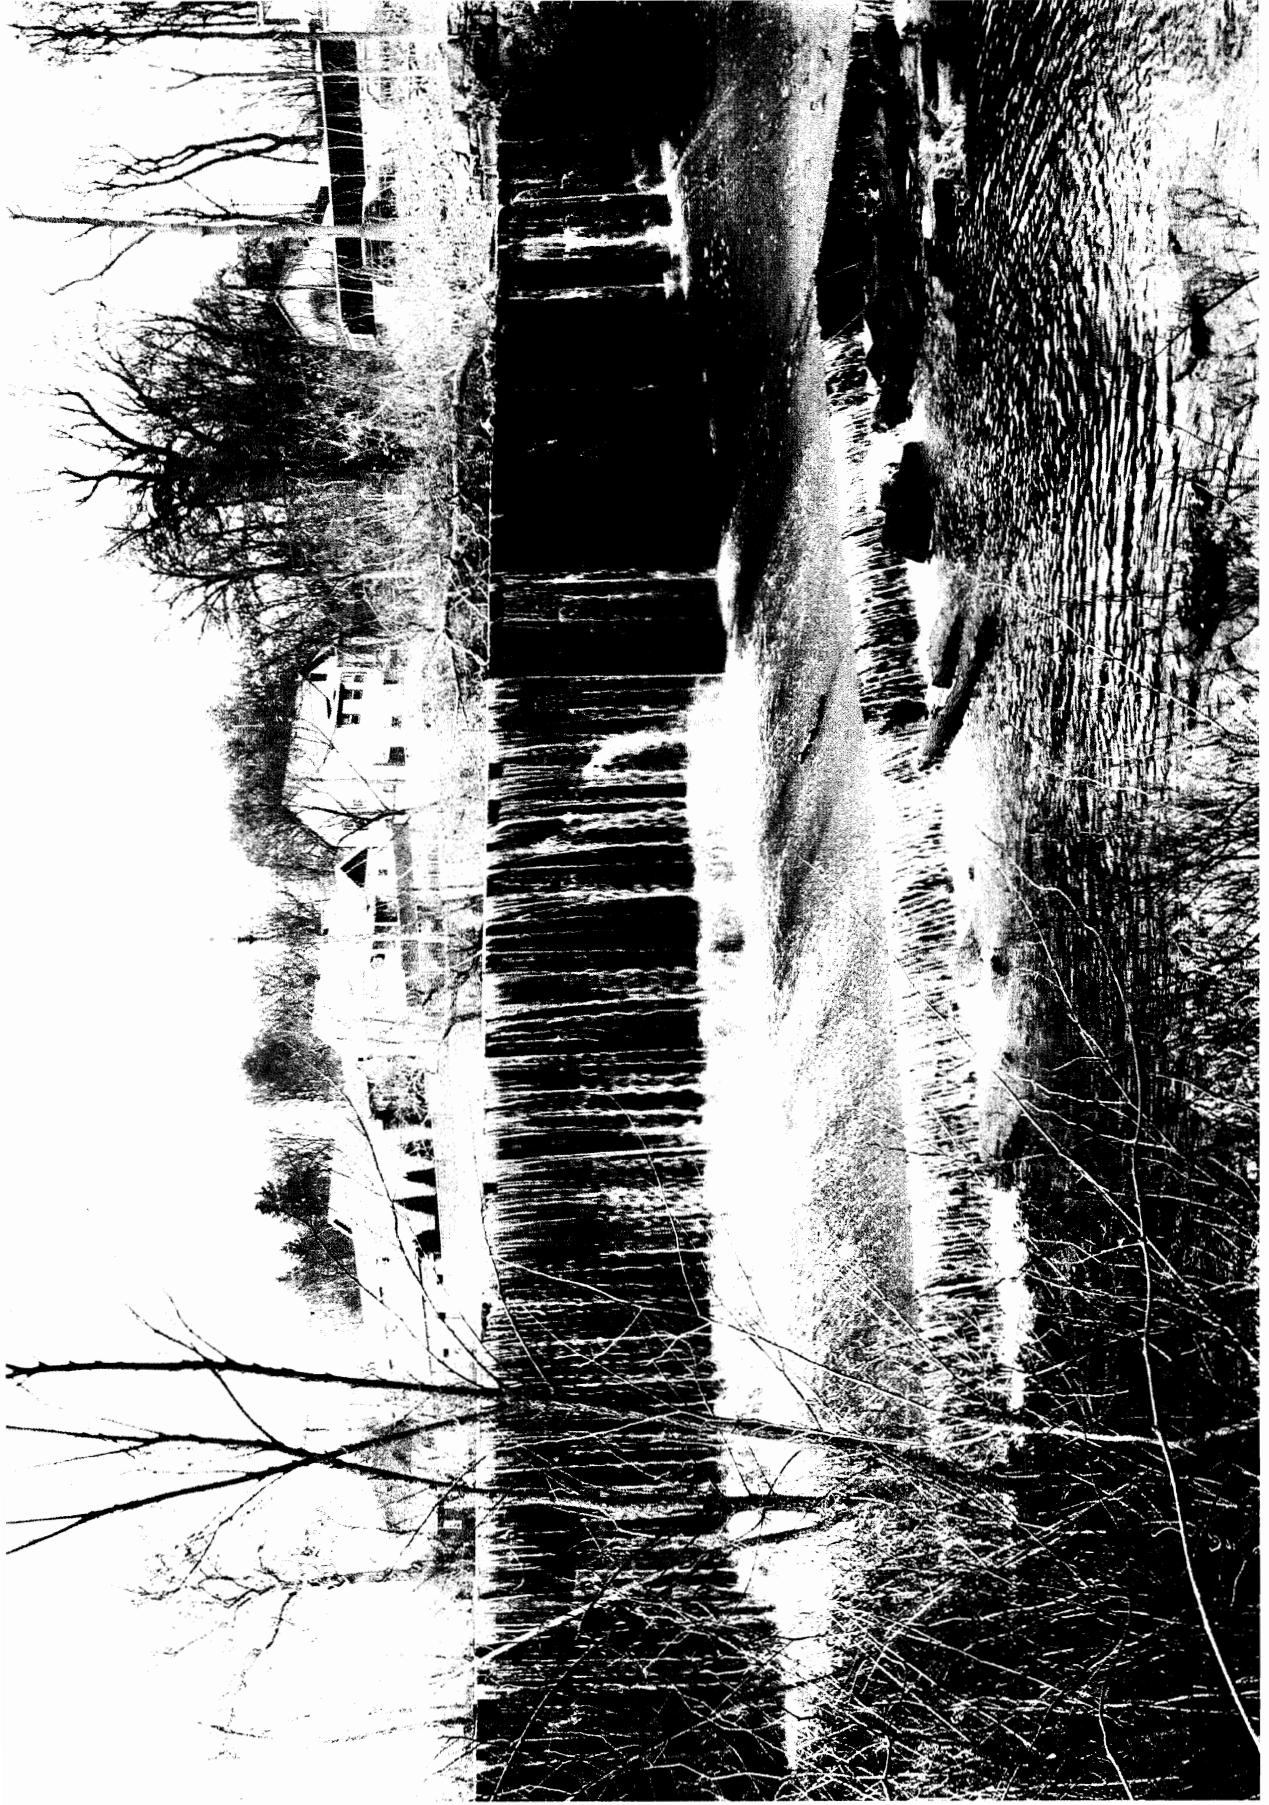
**PIN SHOP POND DAM  
SPILLWAY AND APRON FROM DOWNSTREAM**

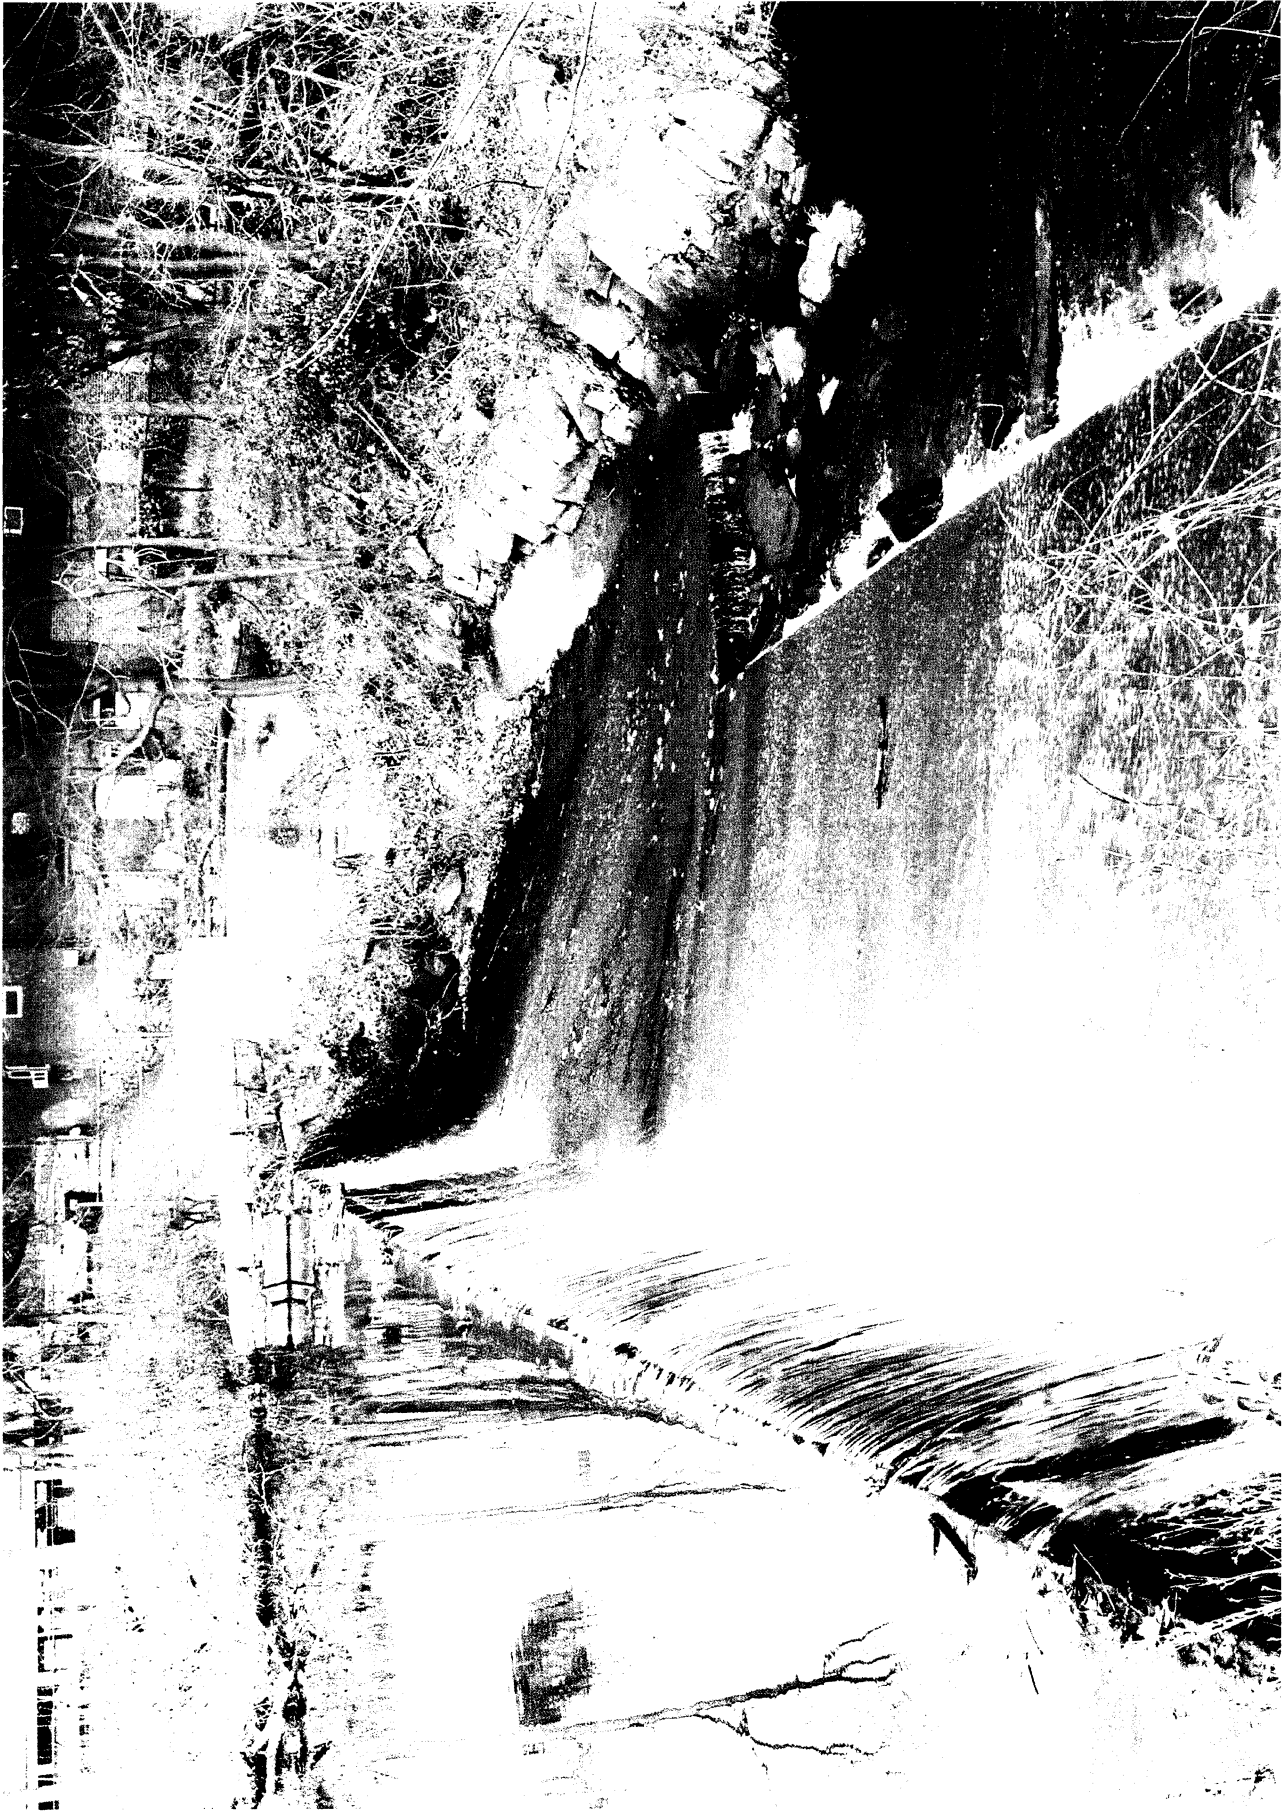
**PIN SHOP POND DAM  
SPILLWAY AND CONCRETE APRON**

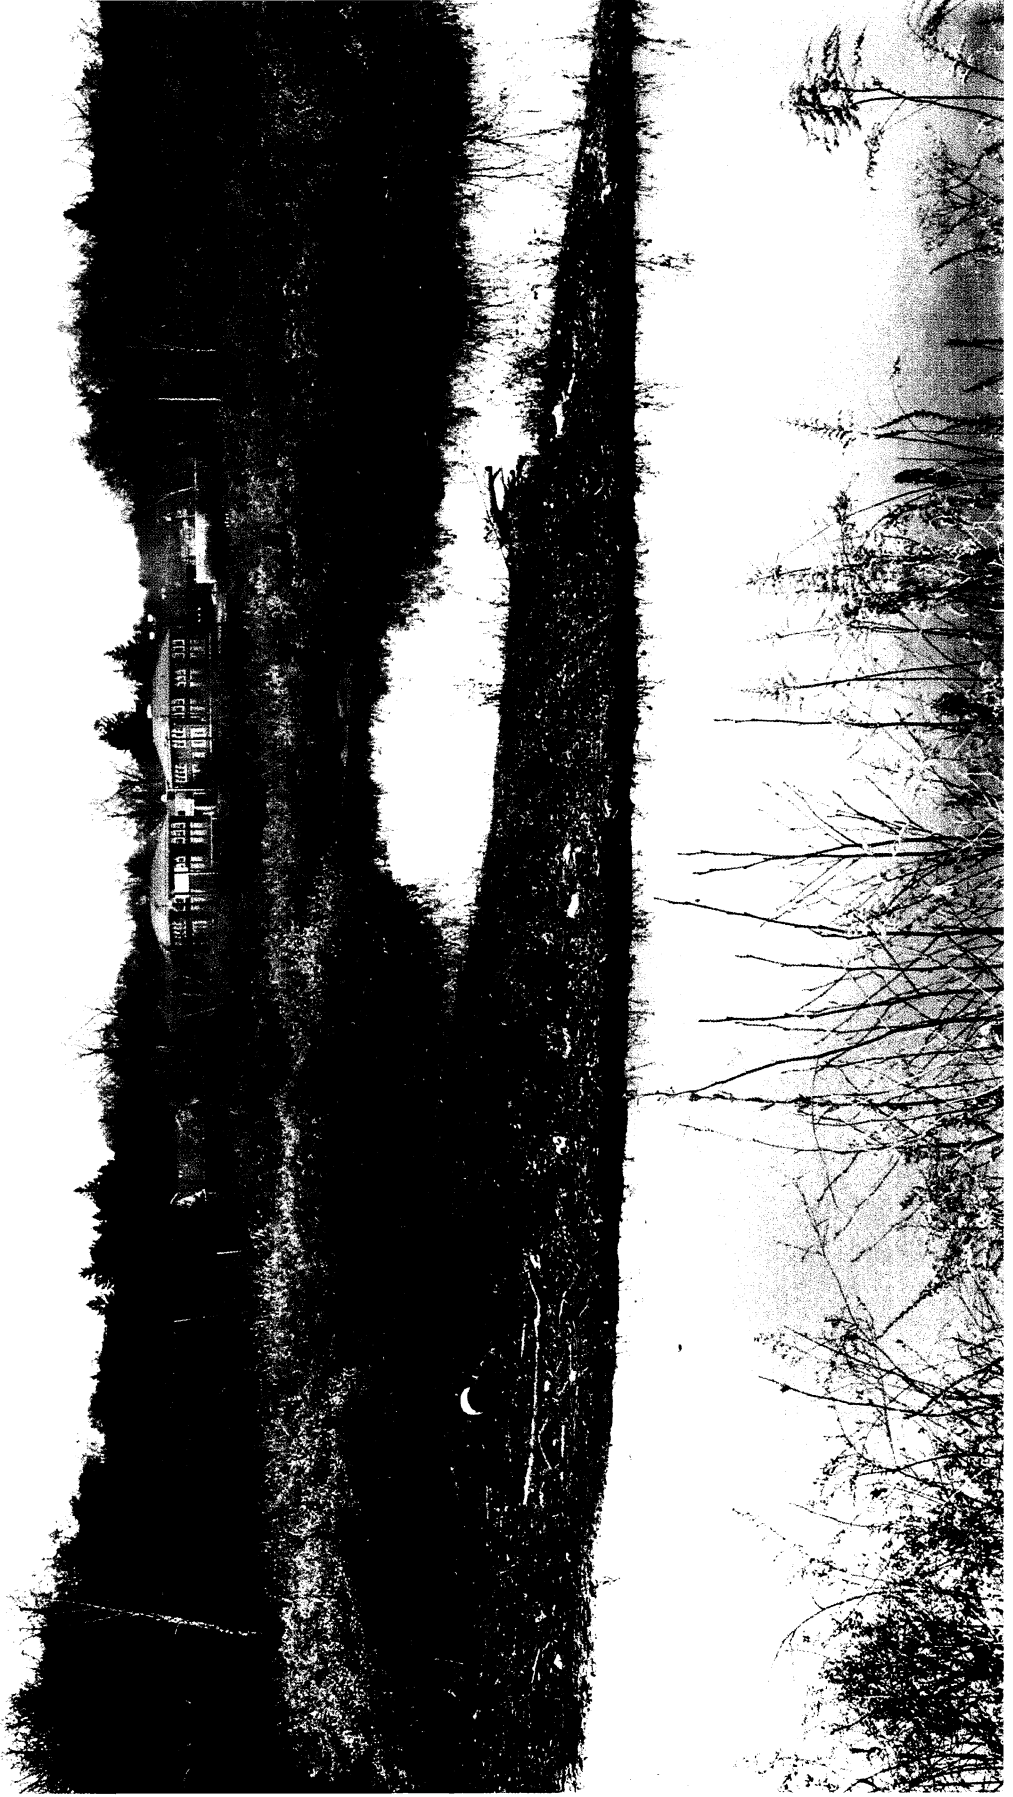
**PIN SHOP POND DAM  
FILLED WITH SEDIMENT AND DEBRIS**

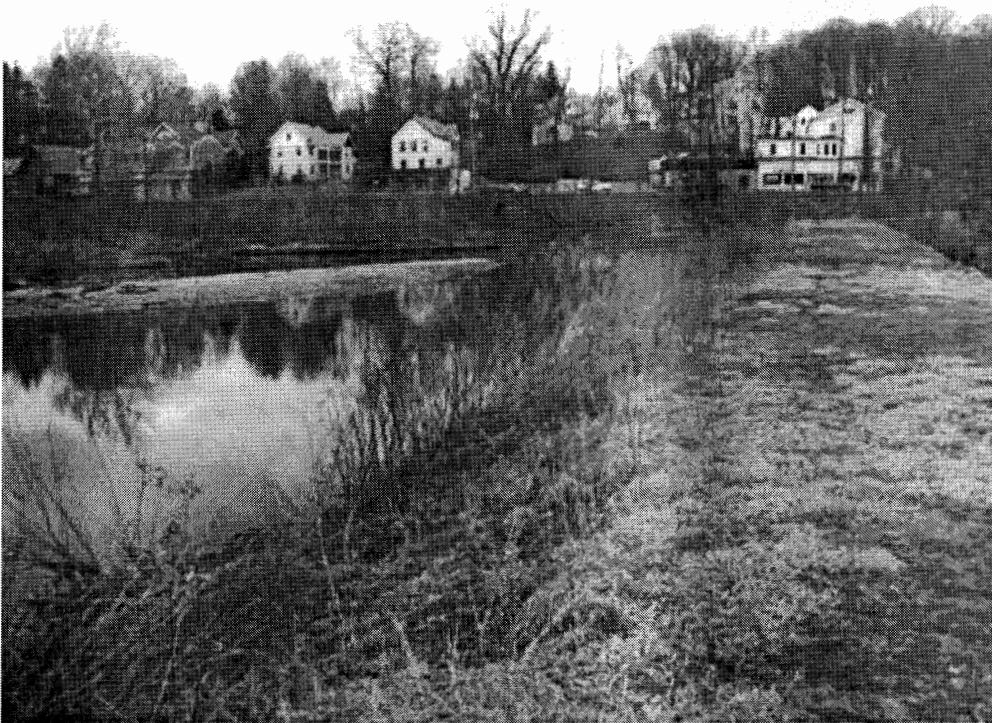
Dam – Pin Shop Pond (3/15/11).

The earthen dam located at the eastern end of Pin Shop Pond is periodically mowed to maintain herbaceous vegetation. The dominant vegetation on the dam includes mowed grasses, evening primrose, Japanese knotweed, goldenrod, multiflora rose, silky dogwood and purple loosestrife.

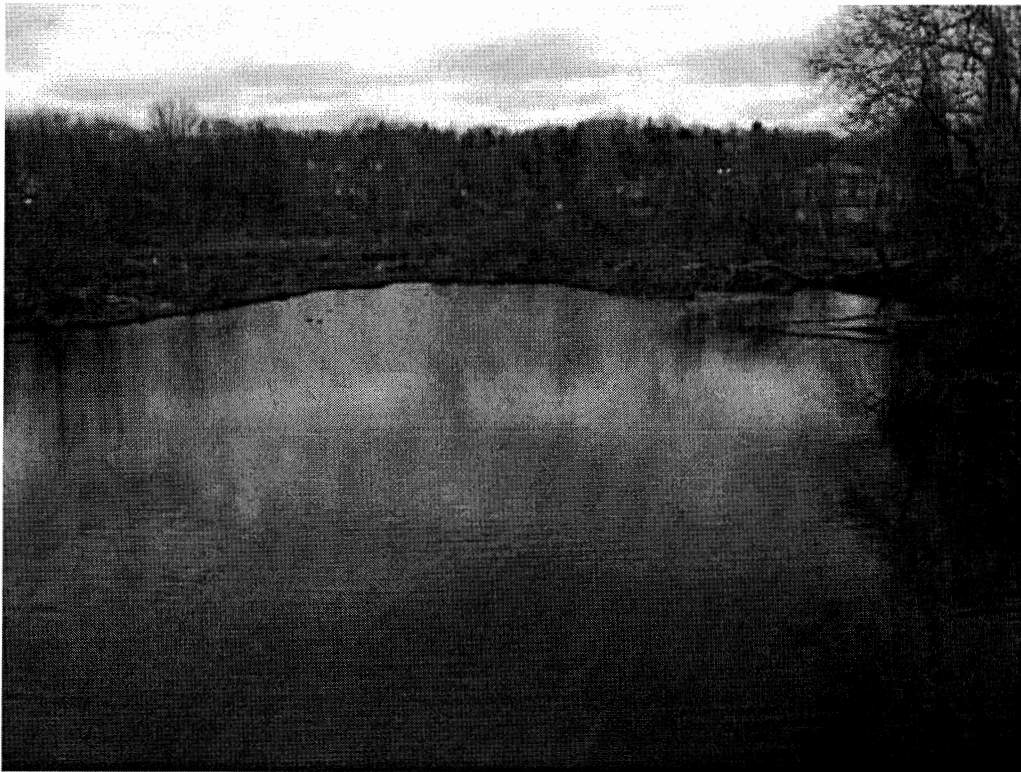
Pin Shop Pond (3/15/11).

earthen dam and concrete spillway is approximately 23 feet high and 480 feet long. Over time the Pin Shop Pond has filled in with sediments. The original pond was approximately 6.5 acres in size. It is now approximately 3.5 acres in size with small islands and peninsulas consisting of alluvium throughout the pond. The average depth of the pond is approximately 1 foot. Due to historic industrial discharges, there are contaminants within the sediments in the pond.

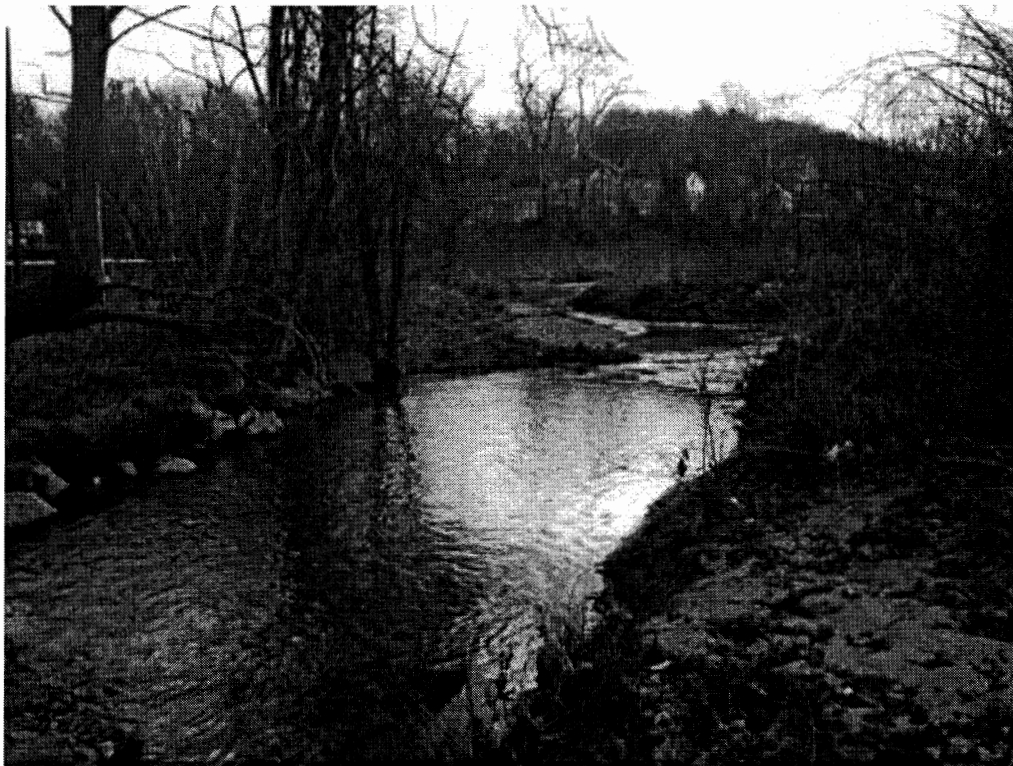
Two perennial watercourses flow into the pond. Wattles Brook flows into the pond from the southwest. This watercourse is approximately 20 feet wide and ranged from 6 inches to 2 feet in depth during the inspection. The substrate of Wattles Brook is comprised of sand, gravel and rocks. Rip Rap has been placed along the northern bank of Wattles Brook in the area behind the library. Steele Brook enters the pond and wetland complex from the north. Steele Brook is approximately 30 to 40 feet wide as it enters the pond. The water depth of Steele Brook ranged from 1 to 3 feet and the substrate of the watercourse consists of sand, gravel and rocks. Steele Brook, in the vicinity of Davis Street, has been channelized by retaining walls and rip rap.

Looking northeasterly at Wattles Brook from wetland (3/15/11).

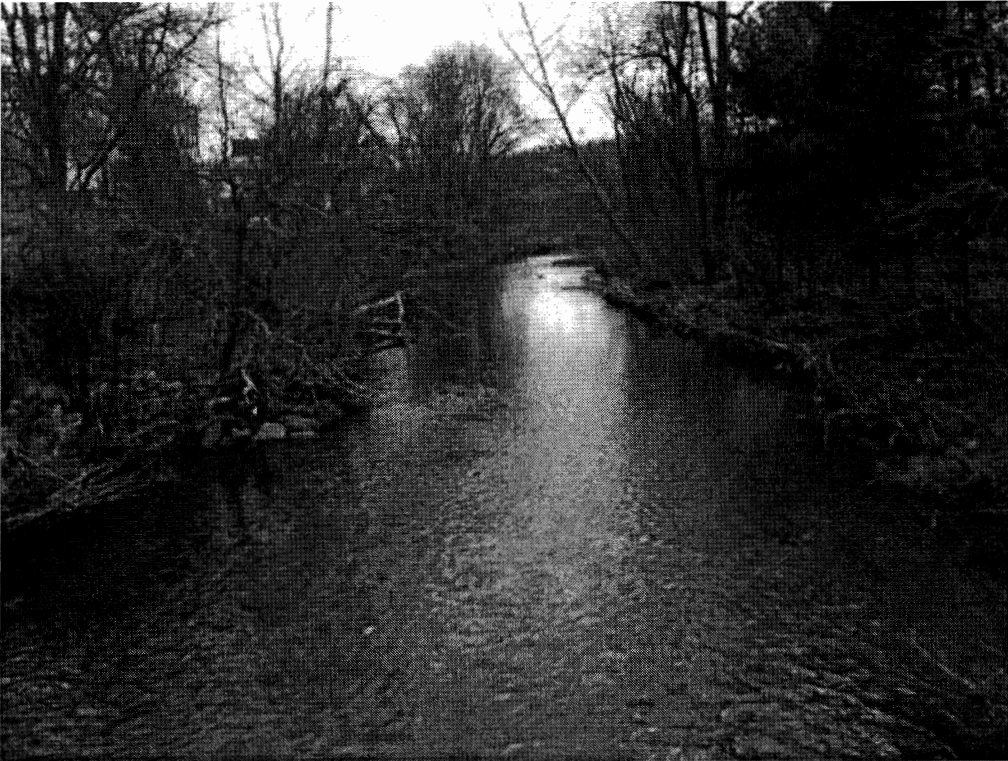
Looking easterly at Steele Brook from Davis Street (3/15/11).

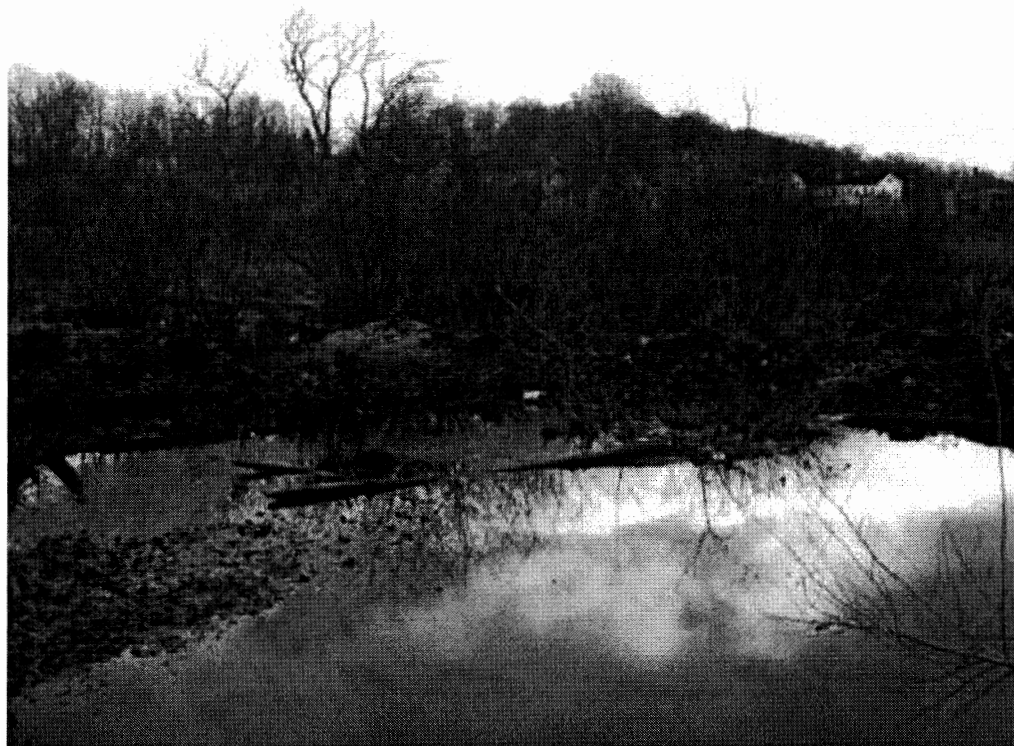
Vegetation within the wetland areas (including the peninsulas and islands) is dense. The dominant species observed during the inspections include red maple, elm, black cherry, sycamore, white and gray birch, locust, red cedar, oaks, catalpa, willows, alder, silky dogwood, elderberry, red osier dogwood, winged euonymus, multiflora rose, tatarian honeysuckle, Japanese barberry, meadowsweet, bittersweet, grape, poison ivy, Japanese knotweed, iris, goldenrod, soft rush, sedges, aster, skunk cabbage, cattail, bindweed and arrow-leaf tearthumb. Several of these species are considered to be invasive.

Portion of Pin Shop Pond and vegetated peninsula (3/15/11).

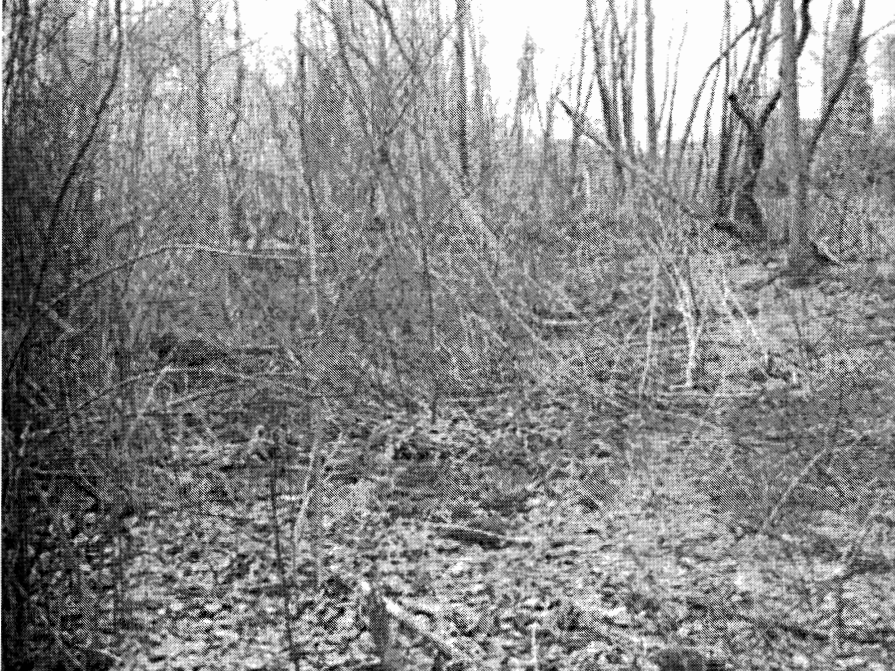
A small, isolated, disturbed wetland is present to the south of Pin Shop Pond. This wetland was identified as both a CT and Federal wetland. The sanitary sewer line passes through the wetland and fill and miscellaneous building debris and rocks surround the small wetland. The soils within the wetland are disturbed. Vegetation within the wetland is dense and provides dense tree canopy cover and moderately dense to dense shrub and herbaceous understory growth. The dominant vegetation within the wetland includes locust, red maple, cottonwood, silky dogwood, multiflora rose, winged euonymus, bittersweet, grape, Japanese knotweed, sedges, soft rush, manna grass, goldenrod and skunk cabbage.

Although no channel exists between the isolated wetland and pond, surface water flows out of the wetland to the north and into the pond. Water flow was observed during the March inspection.

Isolated wetland south of Pin Shop Pond (3/15/11).

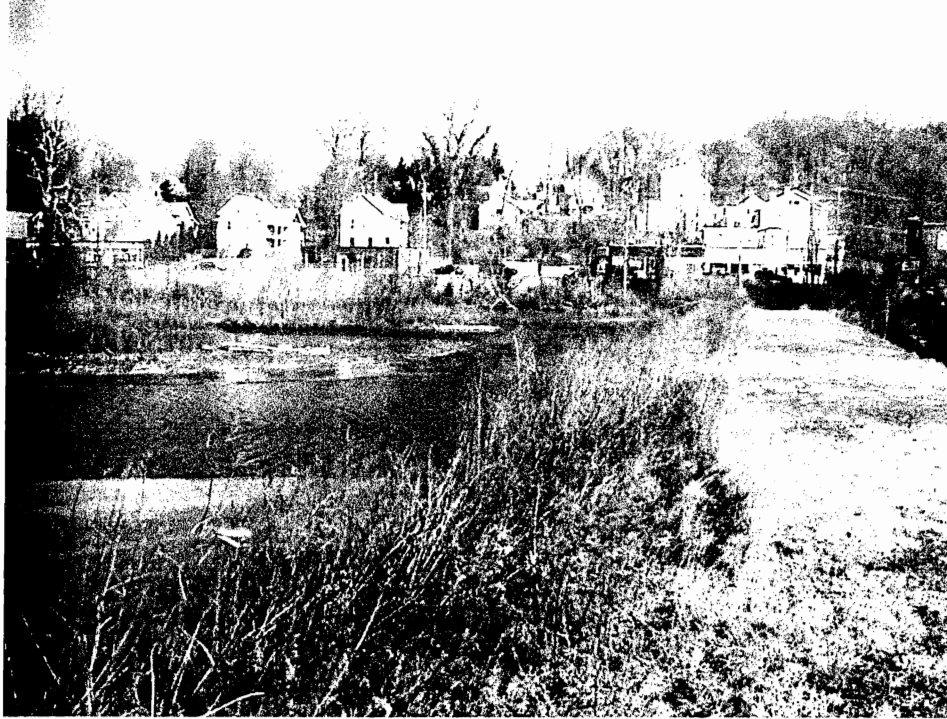
Photo 1-view looking northeasterly across earthen berm dam. The top and southwestern side of the berm is maintained in mowed grass vegetation.

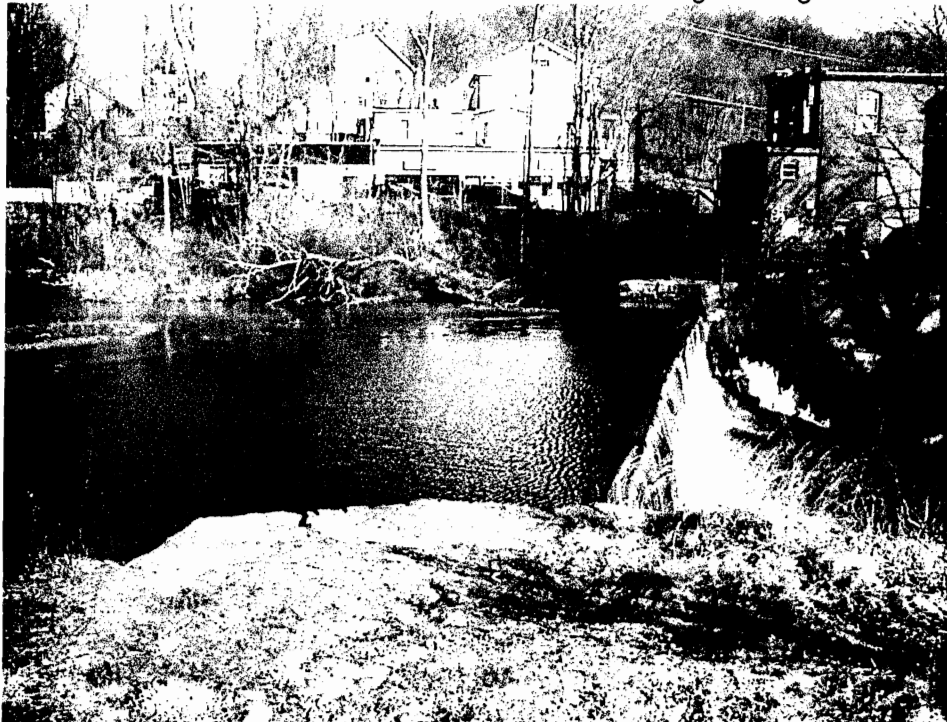
Photo 2-view looking northeast at concrete and stone dam for Pin Ship Pond. Buildings along Main Street are visible behind the pond.

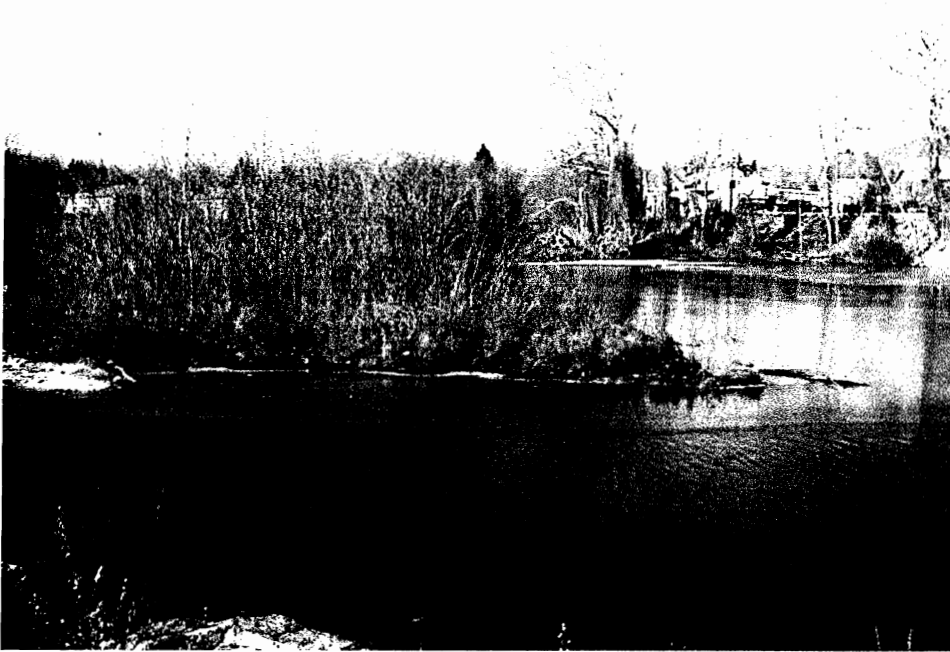
Photo 3-view looking north from top of dam at the northeastern portion of Pin Shop Pond. Elongated peninsula formed by stream sediments extends almost to the dam.

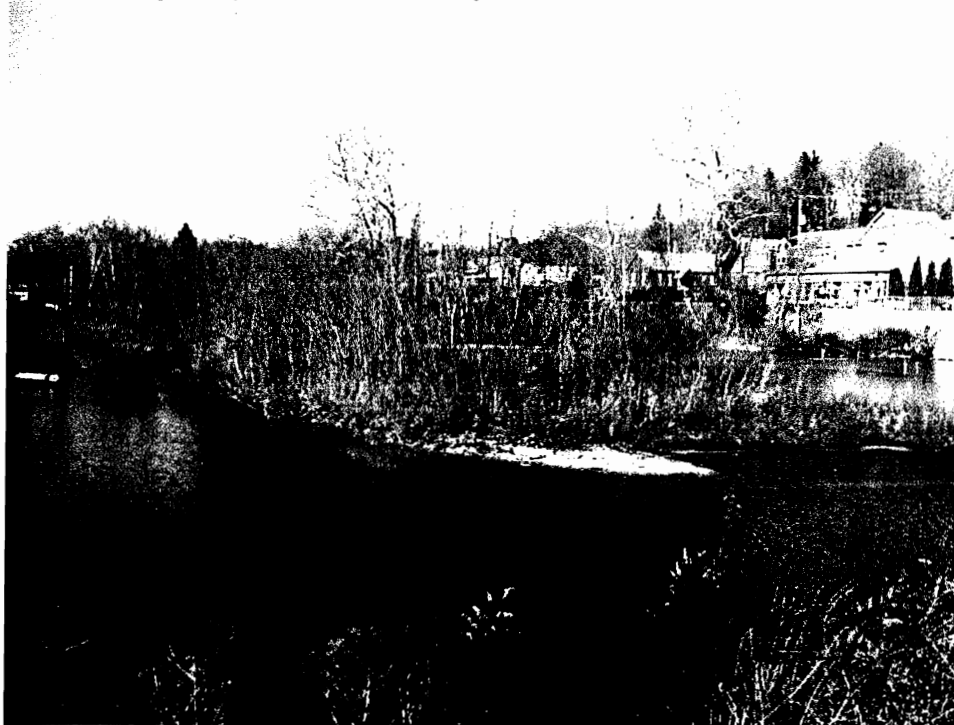
Photo 4- view looking northwest from top of earthen berm dam at stream sediment peninsula. Steele Brook flows along the left side of the peninsula.

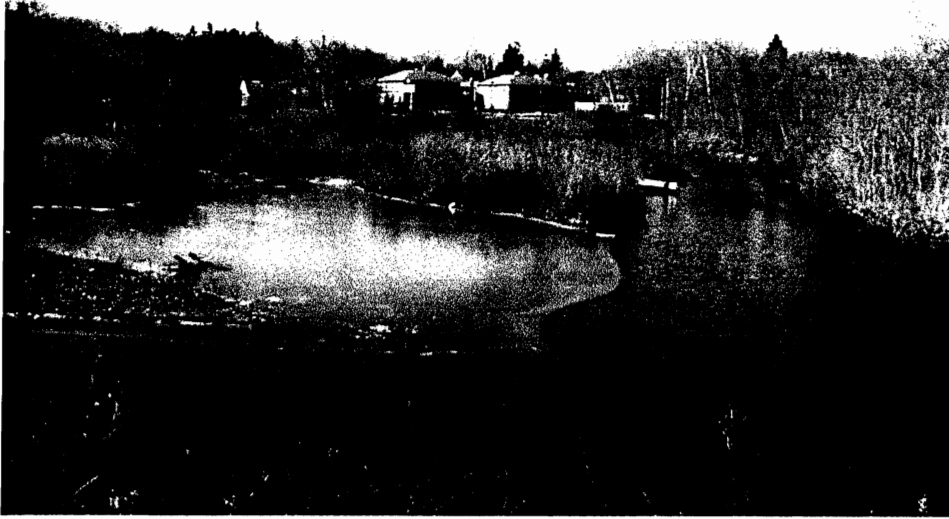
Photo 5-view looking northwesterly from top of earthen berm dam across the sediment-laden remains of Pin Shop Pond. Steele Brook is toward the right side of photo.

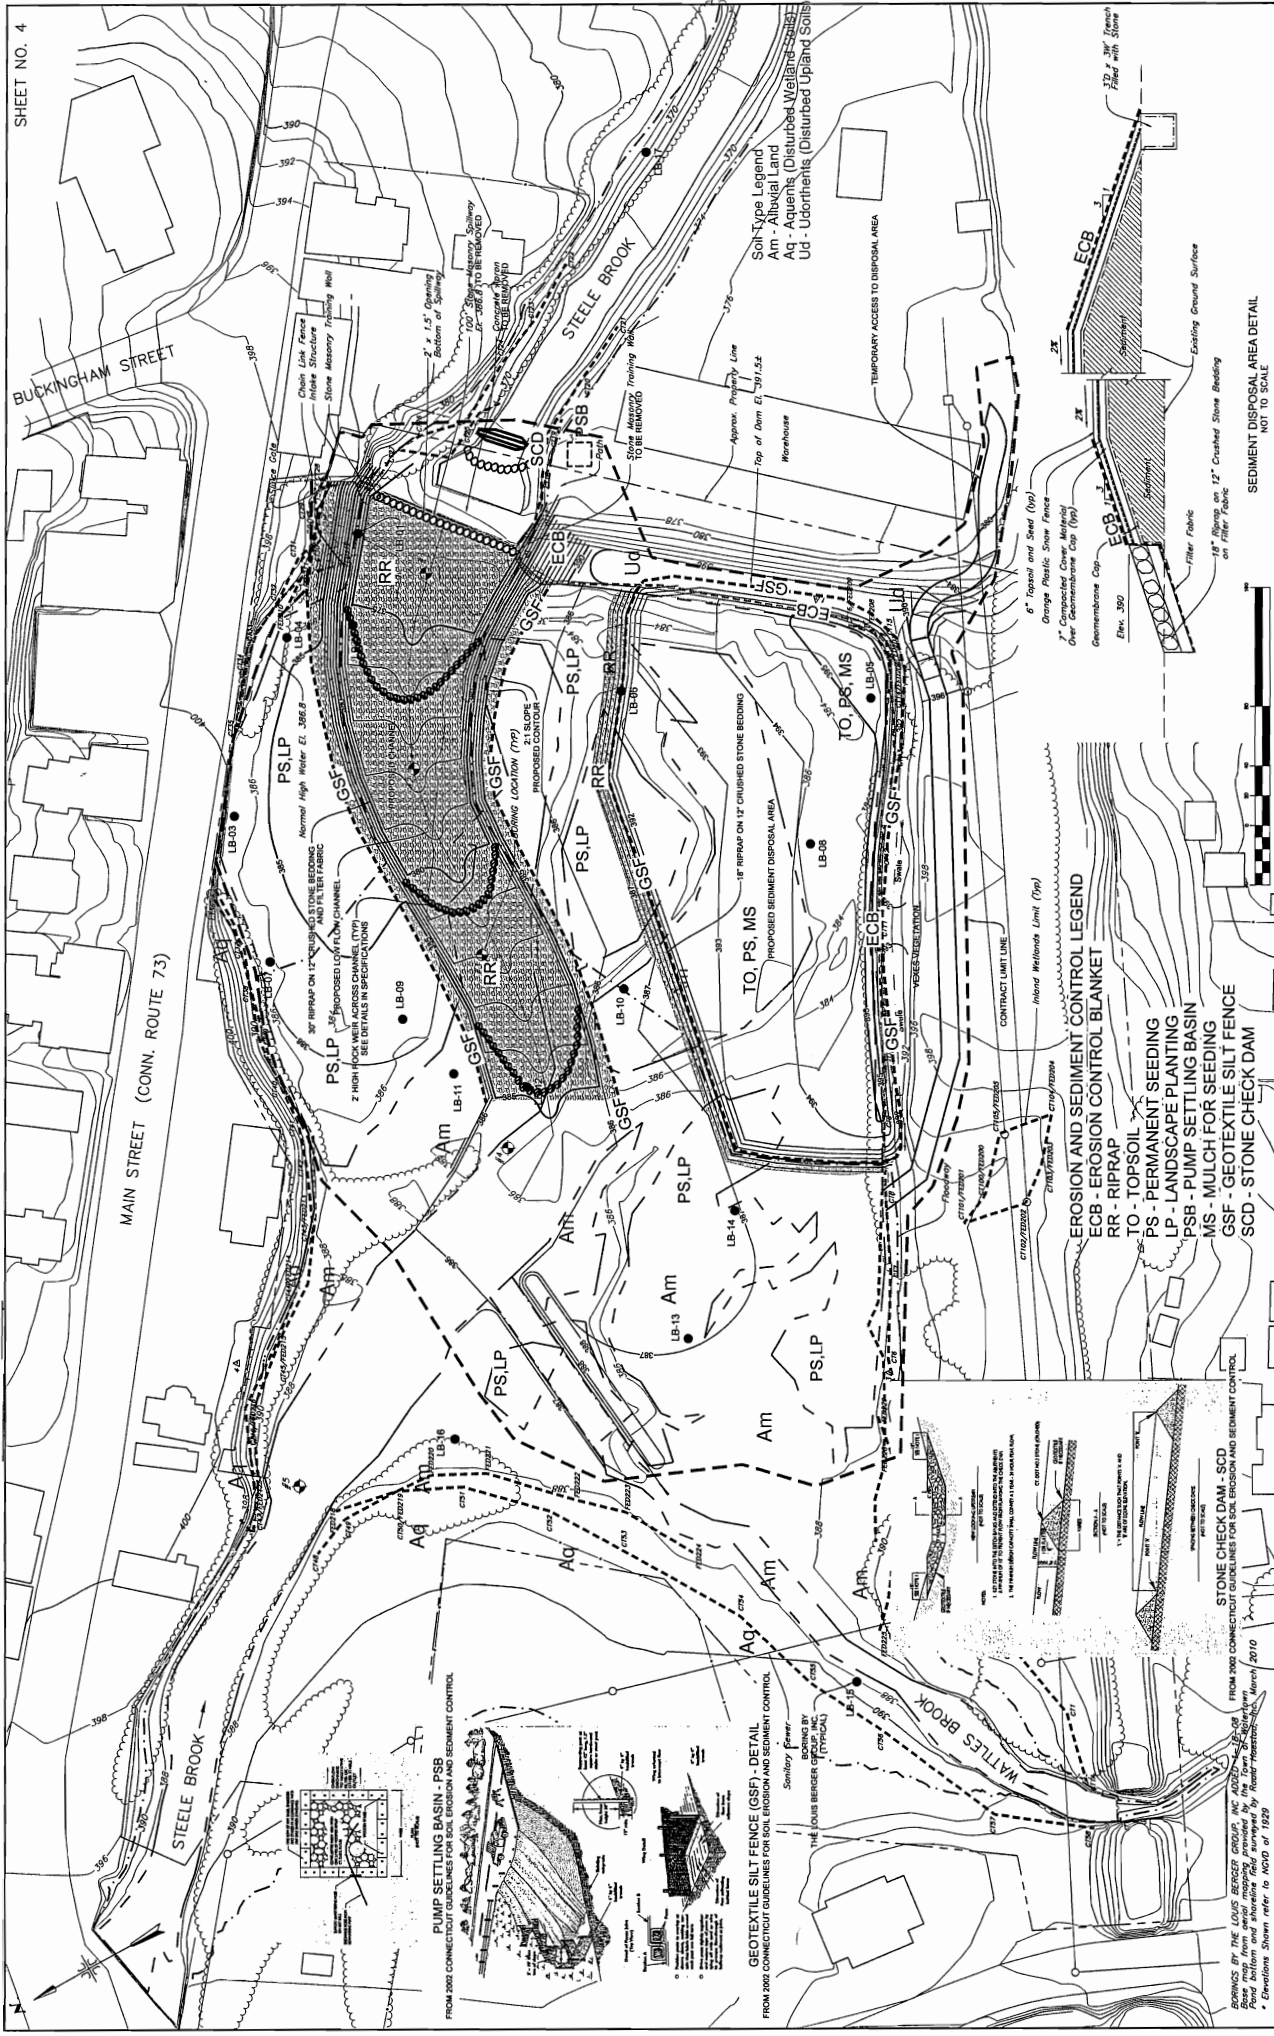
**GEOTEXTILE SILT FENCE (GSF) - DETAIL**  
 FROM 2002 CONNECTICUT GUIDELINES FOR SOIL EROSION AND SEDIMENT CONTROL.  
 Sanitary Fence  
 BORING BY  
 THE LOUIS BERGER GROUP, INC.  
 (1/2004)

**PUMP SETTLING BASIN - PSB**  
 FROM 2002 CONNECTICUT GUIDELINES FOR SOIL EROSION AND SEDIMENT CONTROL.
