Contract #07-16

2010

Spaulding Pond Watershed Management Plan

Prepared by the Eastern Connecticut Conservation District, Inc.

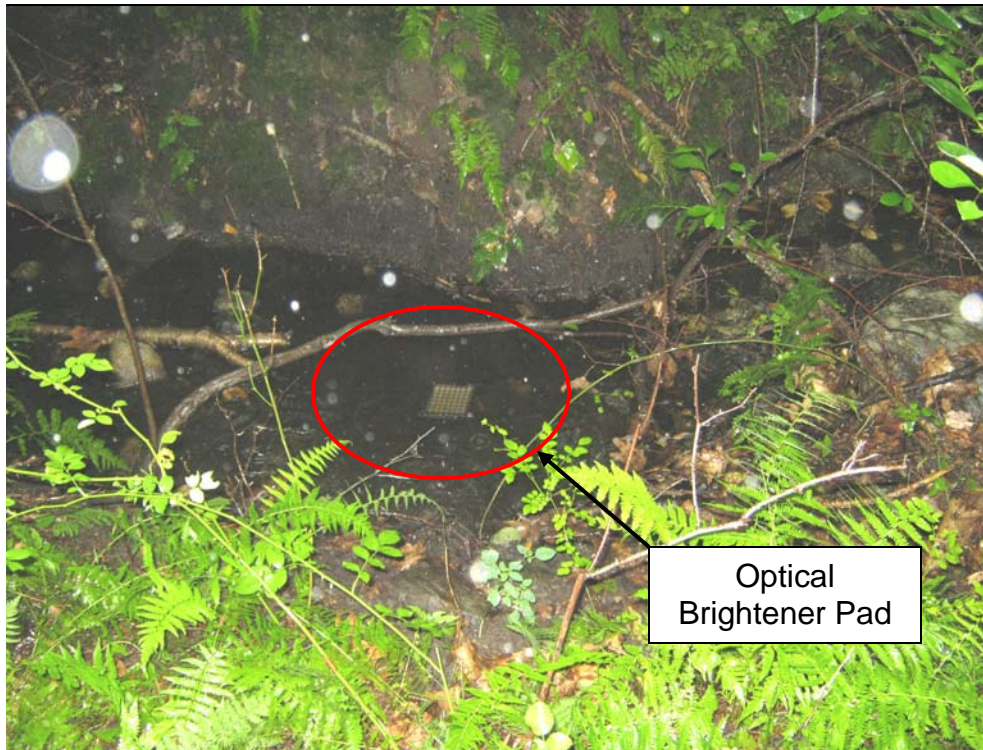
Figure 4: Optical brightener pad in stream north of Ox Hill Road culvert.

In order to determine if septic system effluent or contamination from illicit discharges was present in the stream flowing to Spaulding Pond, optical brightener pads (untreated cotton pads which fluoresce under ultraviolet light if they absorb optical brighteners - a common laundry detergent additive) were placed in the stream just upstream of Ox Hill Road (see location map in Appendix G). In addition to utilizing the optical brightener pad method, Uncas Health District sampled the water for bacteria at both Ox Hill Road and downstream at the pond inlet on the days the optical brightener pad was placed and removed, to provide additional bacterial data.

To test for the presence of septic leachate or other contaminants in the stream flowing to Spaulding Pond, ECCD staff placed an optical brightener pad (OBP) in the stream north of the Ox Hill Road stream crossing for a one week period, from August 16 – 23, 2010. On August 16th and 23rd, the days the OBP was placed and removed, Uncas Health District staff took water samples in two locations, south of the stream crossing at Ox Hill Road and at the stream inlet to Spaulding Pond, to test for bacteria. The OBP tested negative for optical brightener agents. However, the results are considered inconclusive, rather than indicative that no contribution of septic system effluent was present, since a number of variables, including extremely low stream flow related to below average rainfall in the summer of 2010, and whether the seven day sampling period coincided with the laundry schedule of the nearby residences, can affect the results.

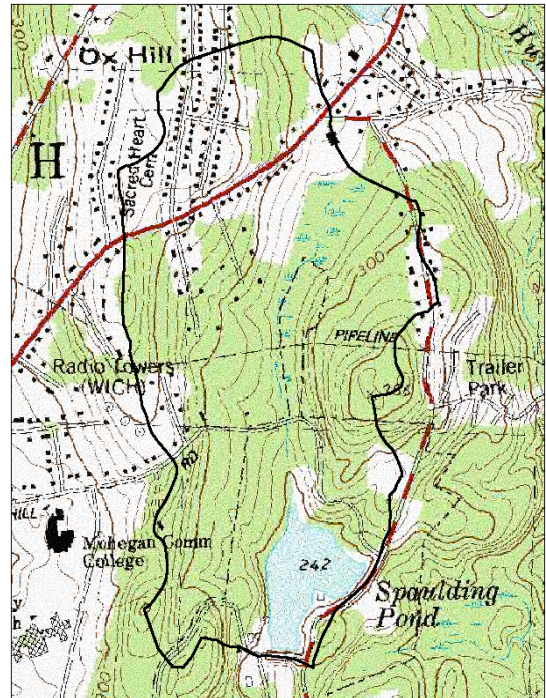
Figure 5: Topography of Spaulding Pond Watershed (USGS).

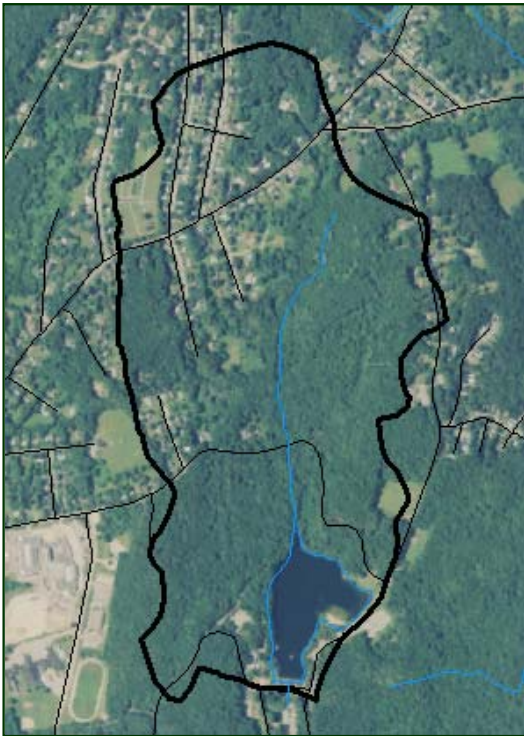
Figure 7: Aerial image of the Spaulding Pond Watershed.

Approximately 54% of the watershed is forested, comprised primarily of deciduous tree species. Suburban development occurs primarily in the north portion of the watershed (see Figure 7). Impervious cover (roadways, driveways, sidewalks) accounts for 22% of the watershed. Approximately 12% of the watershed is turf or grass, 10% is forested wetland or water (including Spaulding Pond), and 2% is designated other grasses (see Figures 8 and 9).

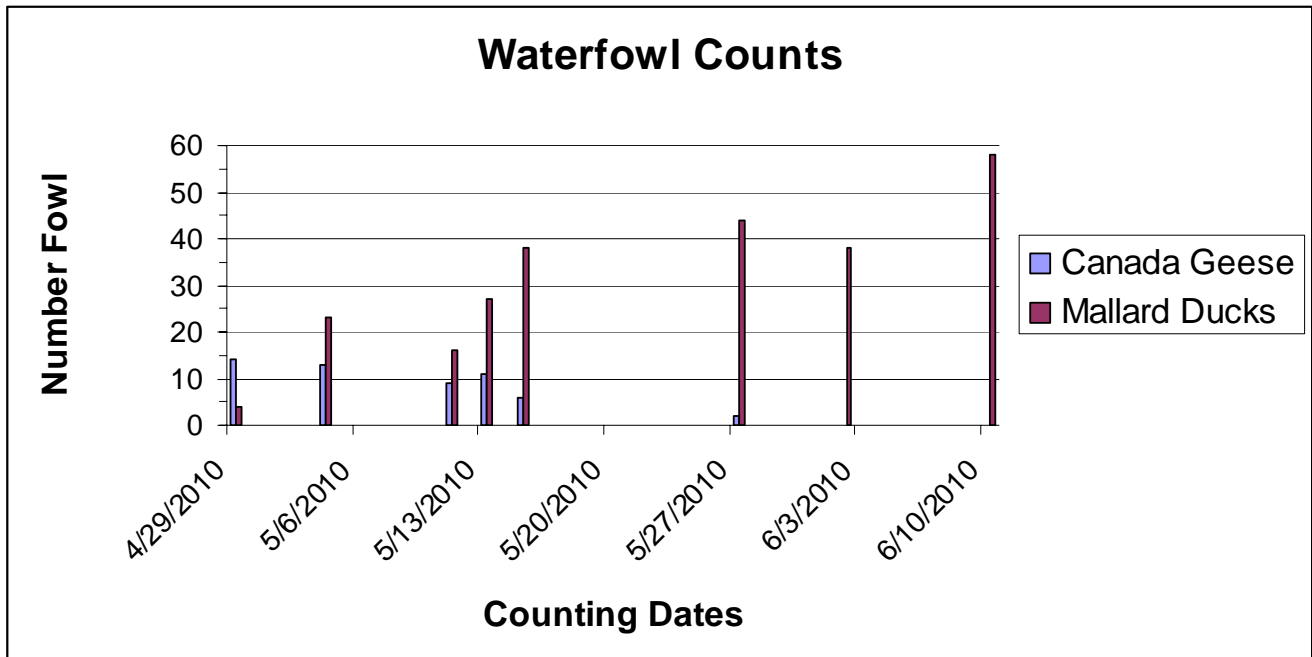
Figure 10: Results of Spring 2010 Waterfowl Counts by Kelly Middle School students.

The 2008 Connecticut Integrated Water Quality Report lists waterfowl as the suspected source of bacterial contamination to Spaulding Pond. Spaulding Pond is seasonally inhabited by a large population of waterfowl. The primary species include Canada geese and mallard ducks, although other (unidentified) ducks species were observed. Students from a nearby middle school were recruited to document bird populations, including breeding/nesting pairs of Canada geese, and offspring, from April to June 2010. The largest number of Canada geese counted, 14, was documented on April 29th. On the same day students observed 6 possible nesting pairs of geese and one gosling. The largest number of Mallard ducks, 58, was counted on June 10th. Unofficial counts by ECCD staff over the course of the investigation indicated the Mallard duck population was maintained at approximately that level throughout the summer.

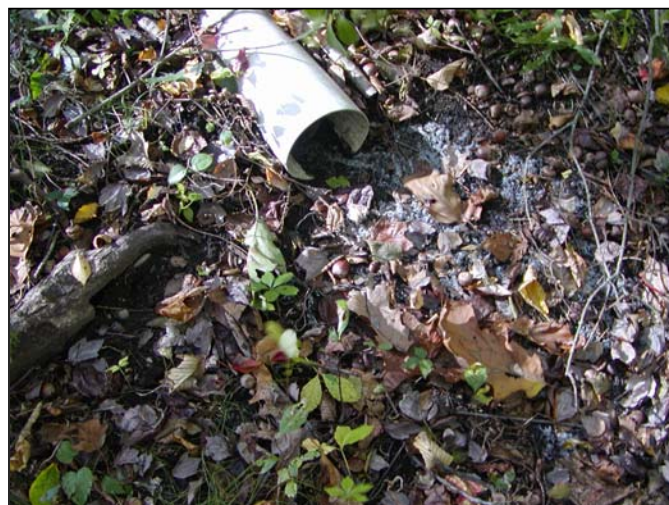
Figure 12: Fungal growth associated with the 6" PVC pipe discharging near the unnamed stream.

A reconnaissance survey of the stream identified a property on Ox Hill Road from which three drainage pipes discharged near the stream. One of the pipes had fungal growth associated with the area of discharge.

The site was reported to and field inspected by Uncas Health District personnel in dry weather when no discharge was being emitted by any of the pipes. We recommend that Uncas Health District check the pipes periodically, especially after a significant rain, to ensure that the drains are discharging clean water.

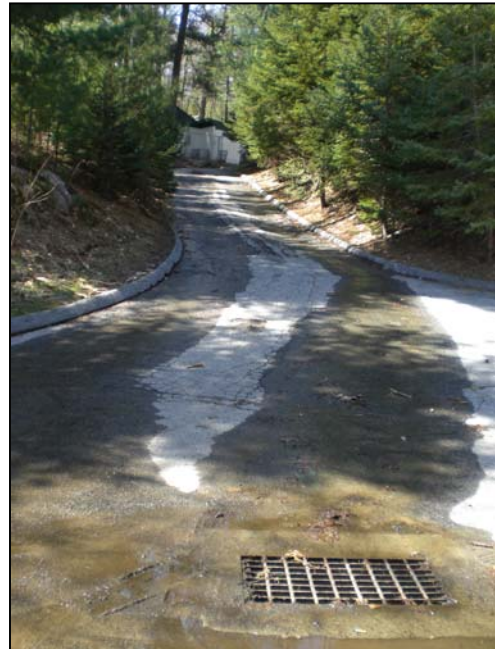
Figure 13: Overland Flow from the Animal Control Facility to a Storm Drain at the Maintenance Garage.

Storm run-off from the existing animal control facility has been observed flowing to a storm drain located behind the park maintenance/public restroom building (Figure 12). Investigation indicates this storm drain does not outlet to Spaulding Pond, but rather has its discharge point south of the pond.

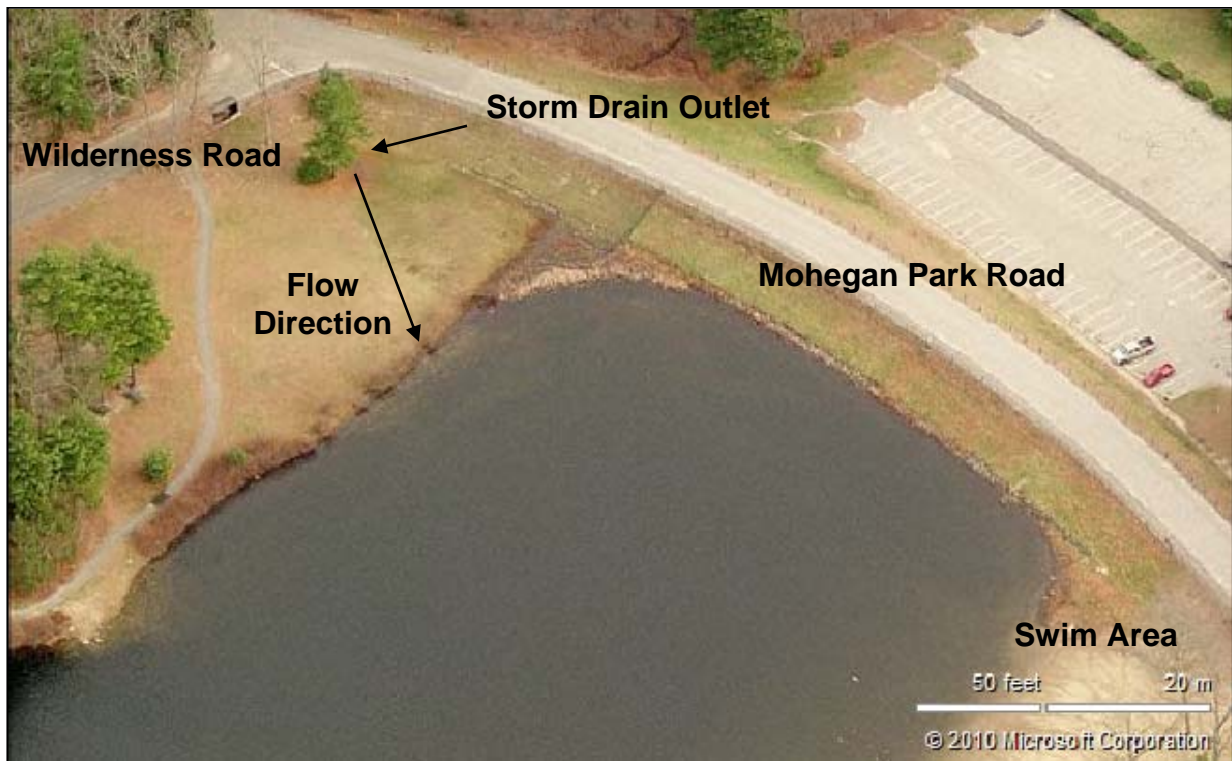
Figure 14: Location of storm drain outlet from Mohegan Park Road relative to the swimming area.

The one area where storm flow may contribute to bacteria loading is a storm drain near Wilderness Road (on the north side of Spaulding Pond) that outlets onto the grassy area north of the swimming beach (see Figures 13 and 14). After heavy rain events, water discharging from this outlet may flow across the land surface near the grassy area where waterfowl forage and goose feces have been observed, transporting bacteria into the pond. Establishment of a vegetative buffer along the lake shore, which is one of this Plan's recommendations, would intercept much of the runoff and reduce the contamination potential.

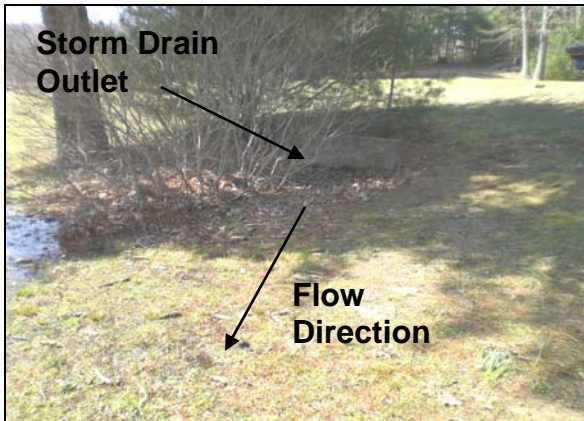
Figure 15a: Storm drain outlet across from the beach area.

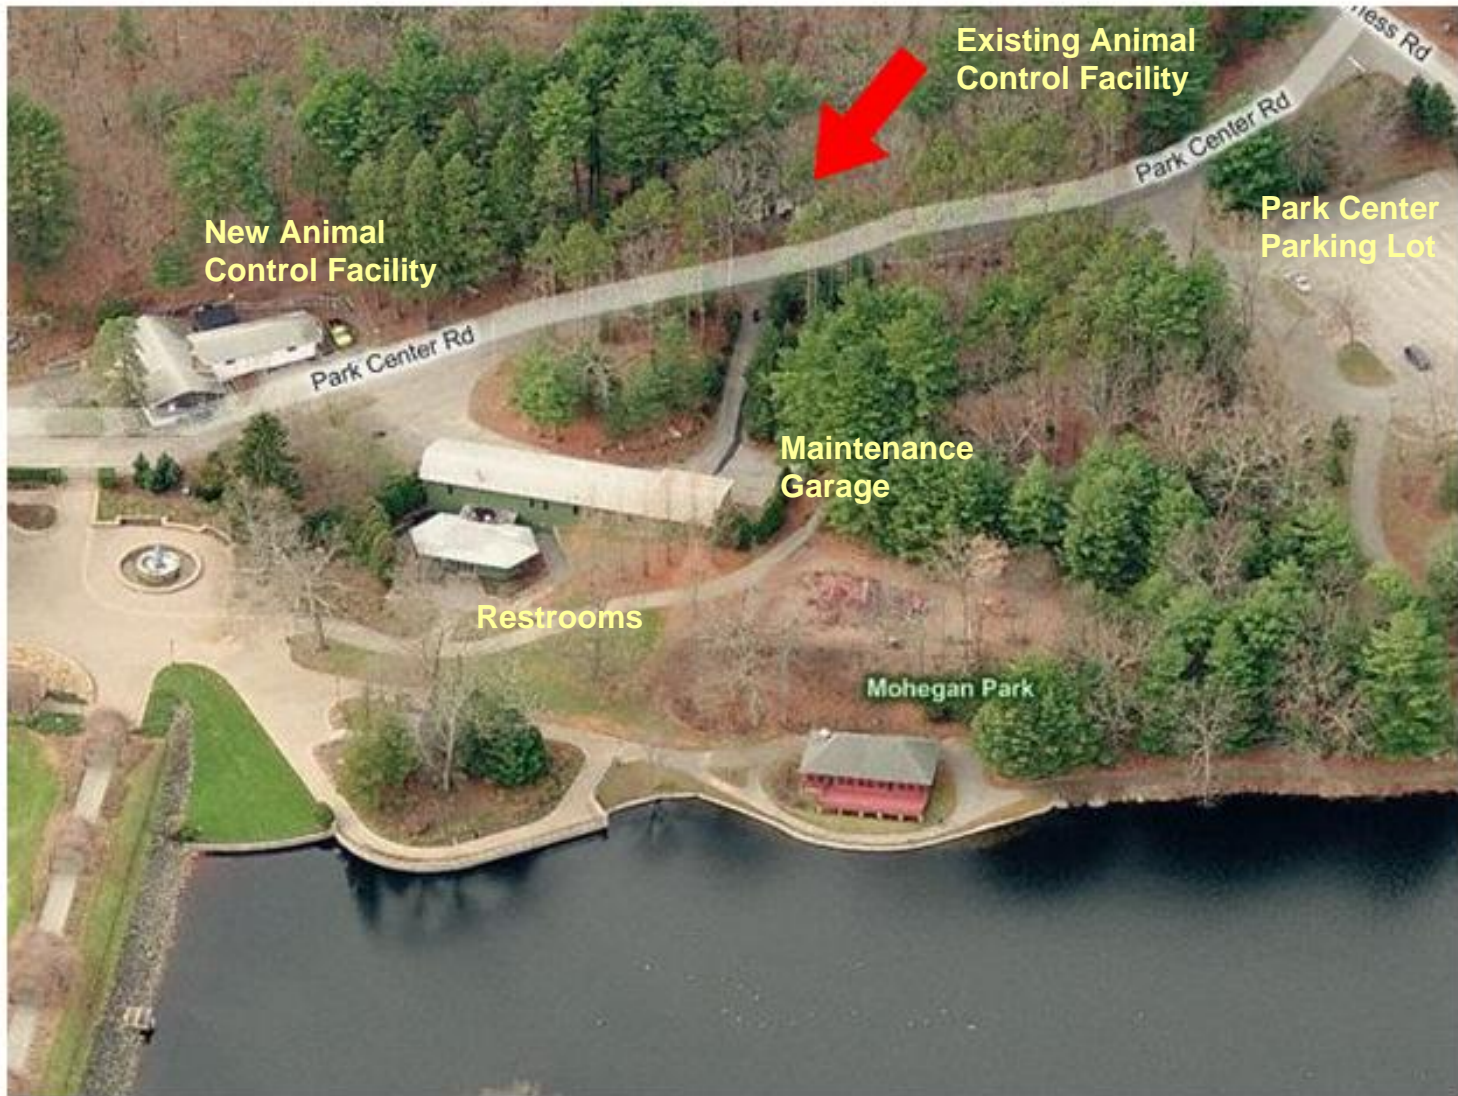
APPENDIX G: Location of Animal Control Facility within Mohegan Park

Dog Pound located near Spaulding Pond
