Connecticut Department of
**ENERGY &
ENVIRONMENTAL
PROTECTION**

Contaminated Sites

Case #1 (Potable Water)
Durham Meadows Federal
Superfund Site

Case #2 (Vapor Intrusion) Milford Cleaning Village

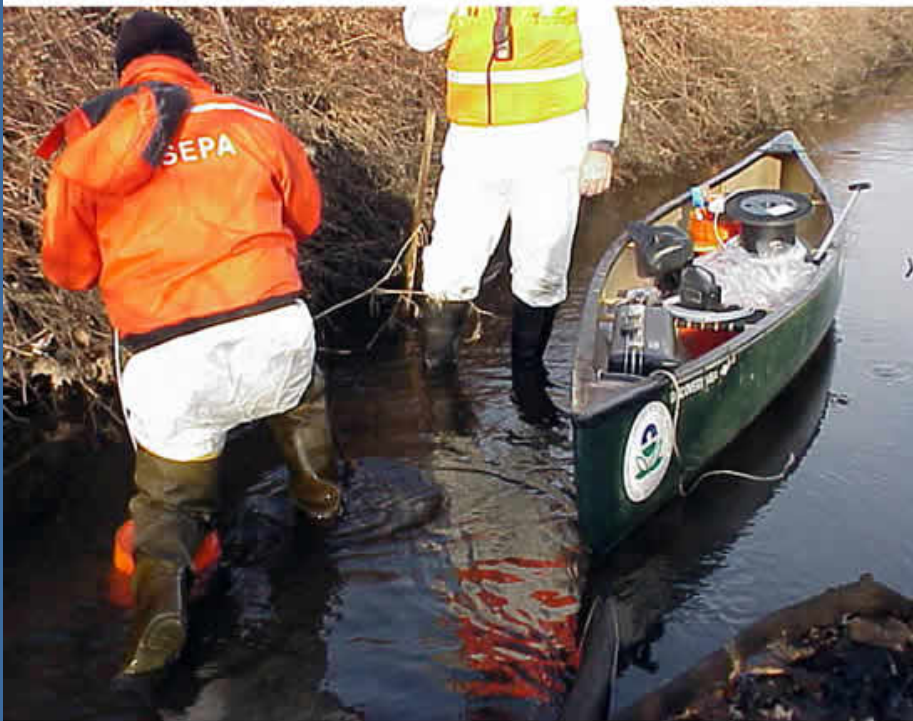
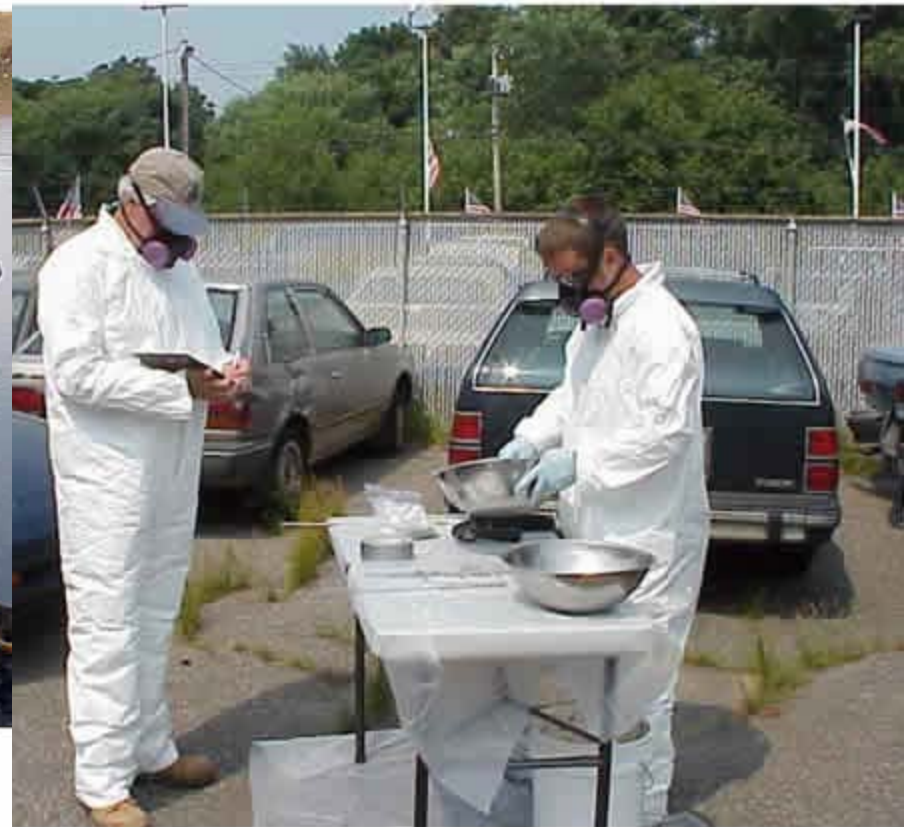
Phase II

Environmental Sampling to confirm or deny the presence of contamination

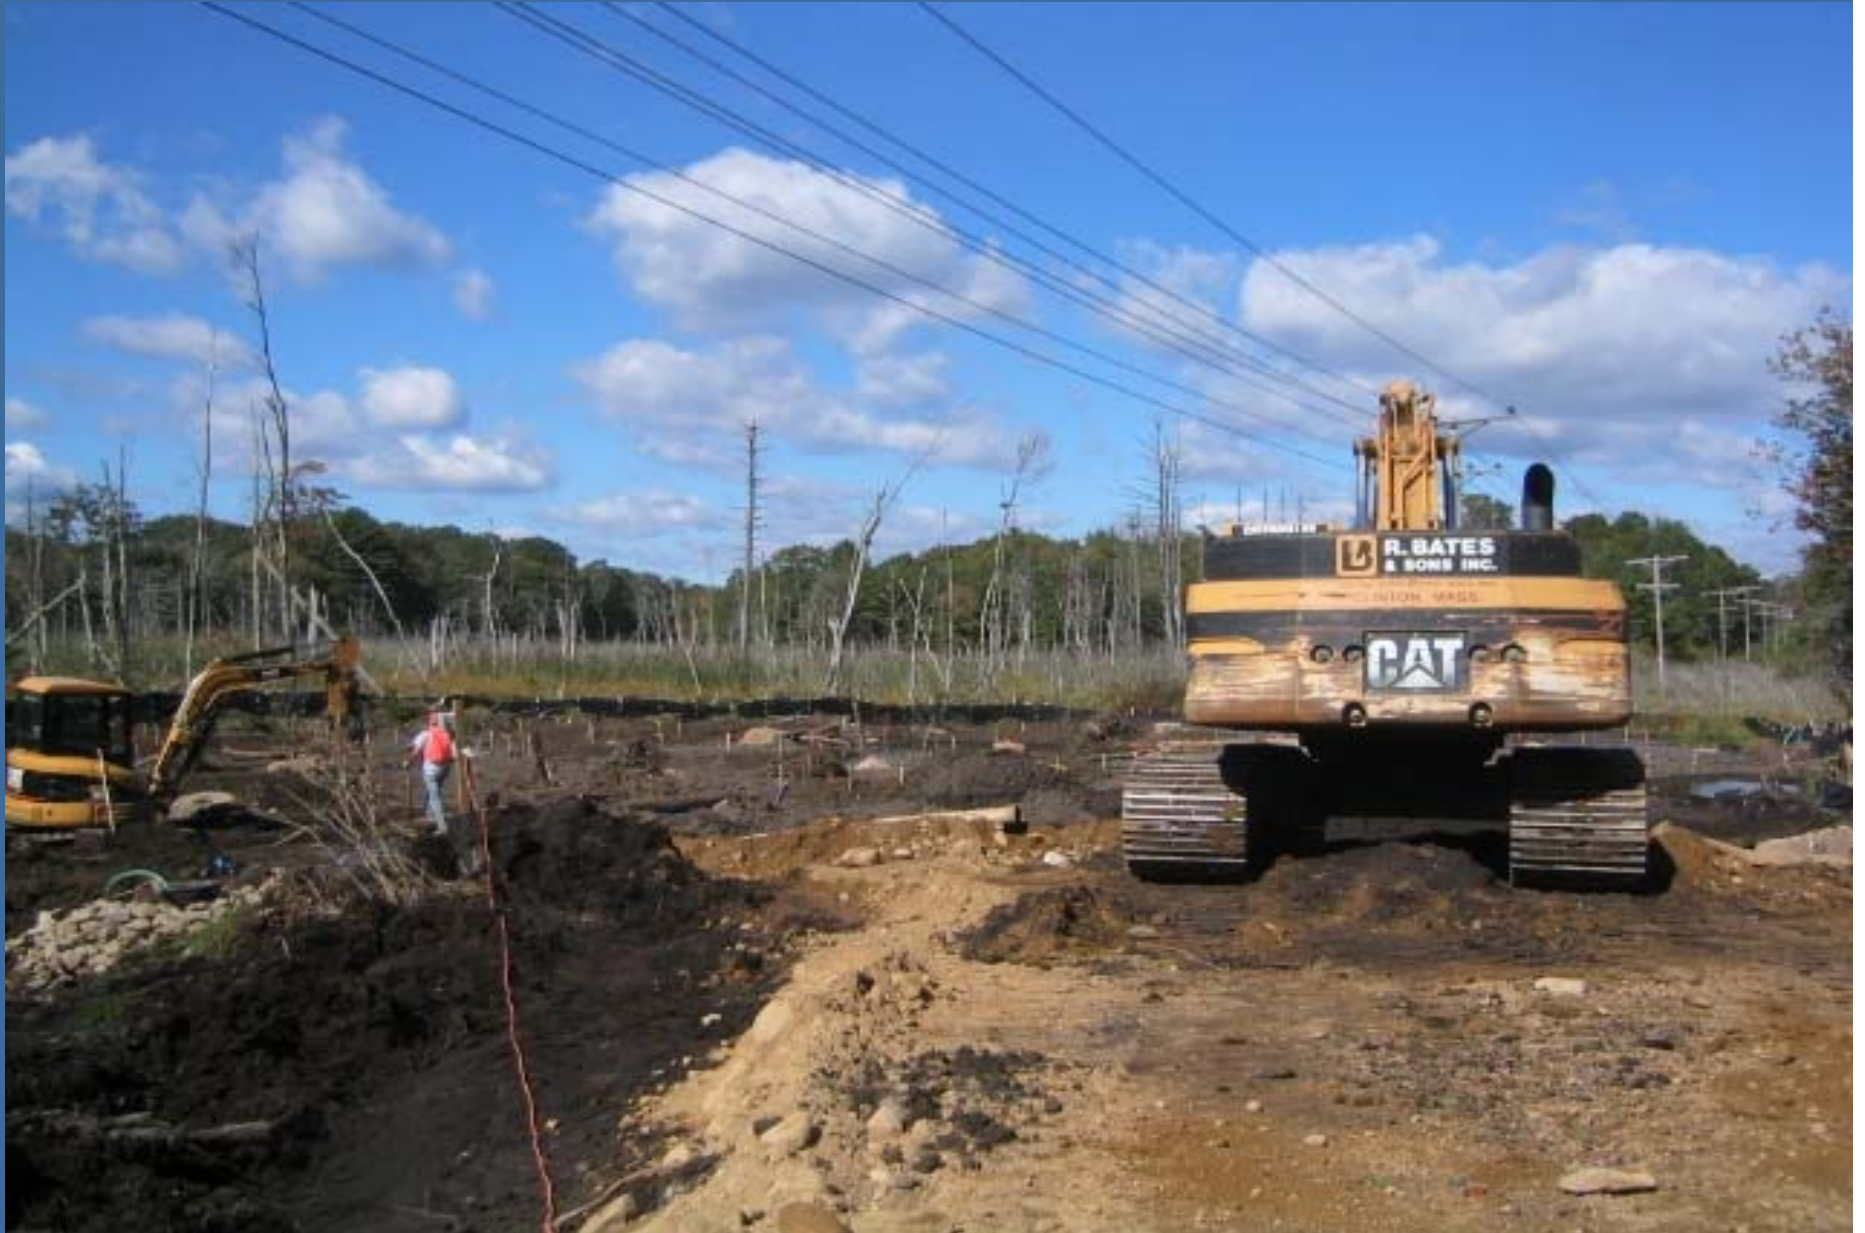
Remediation Strategy - excavation

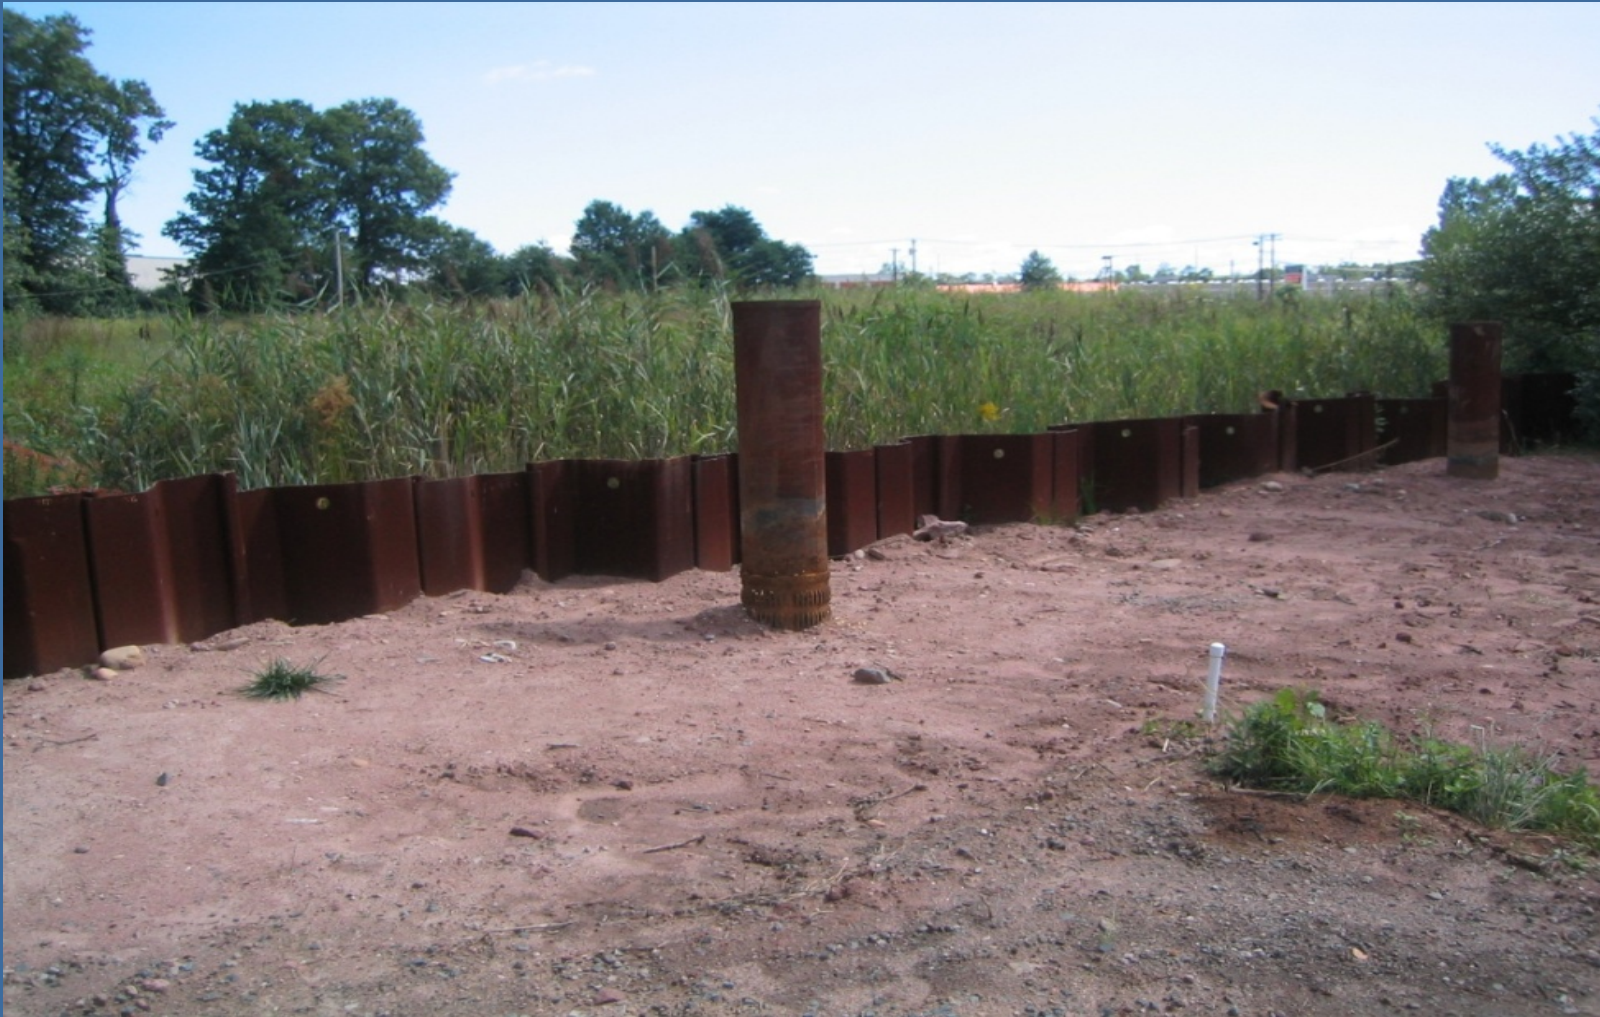
Remediation Strategy – product recovery

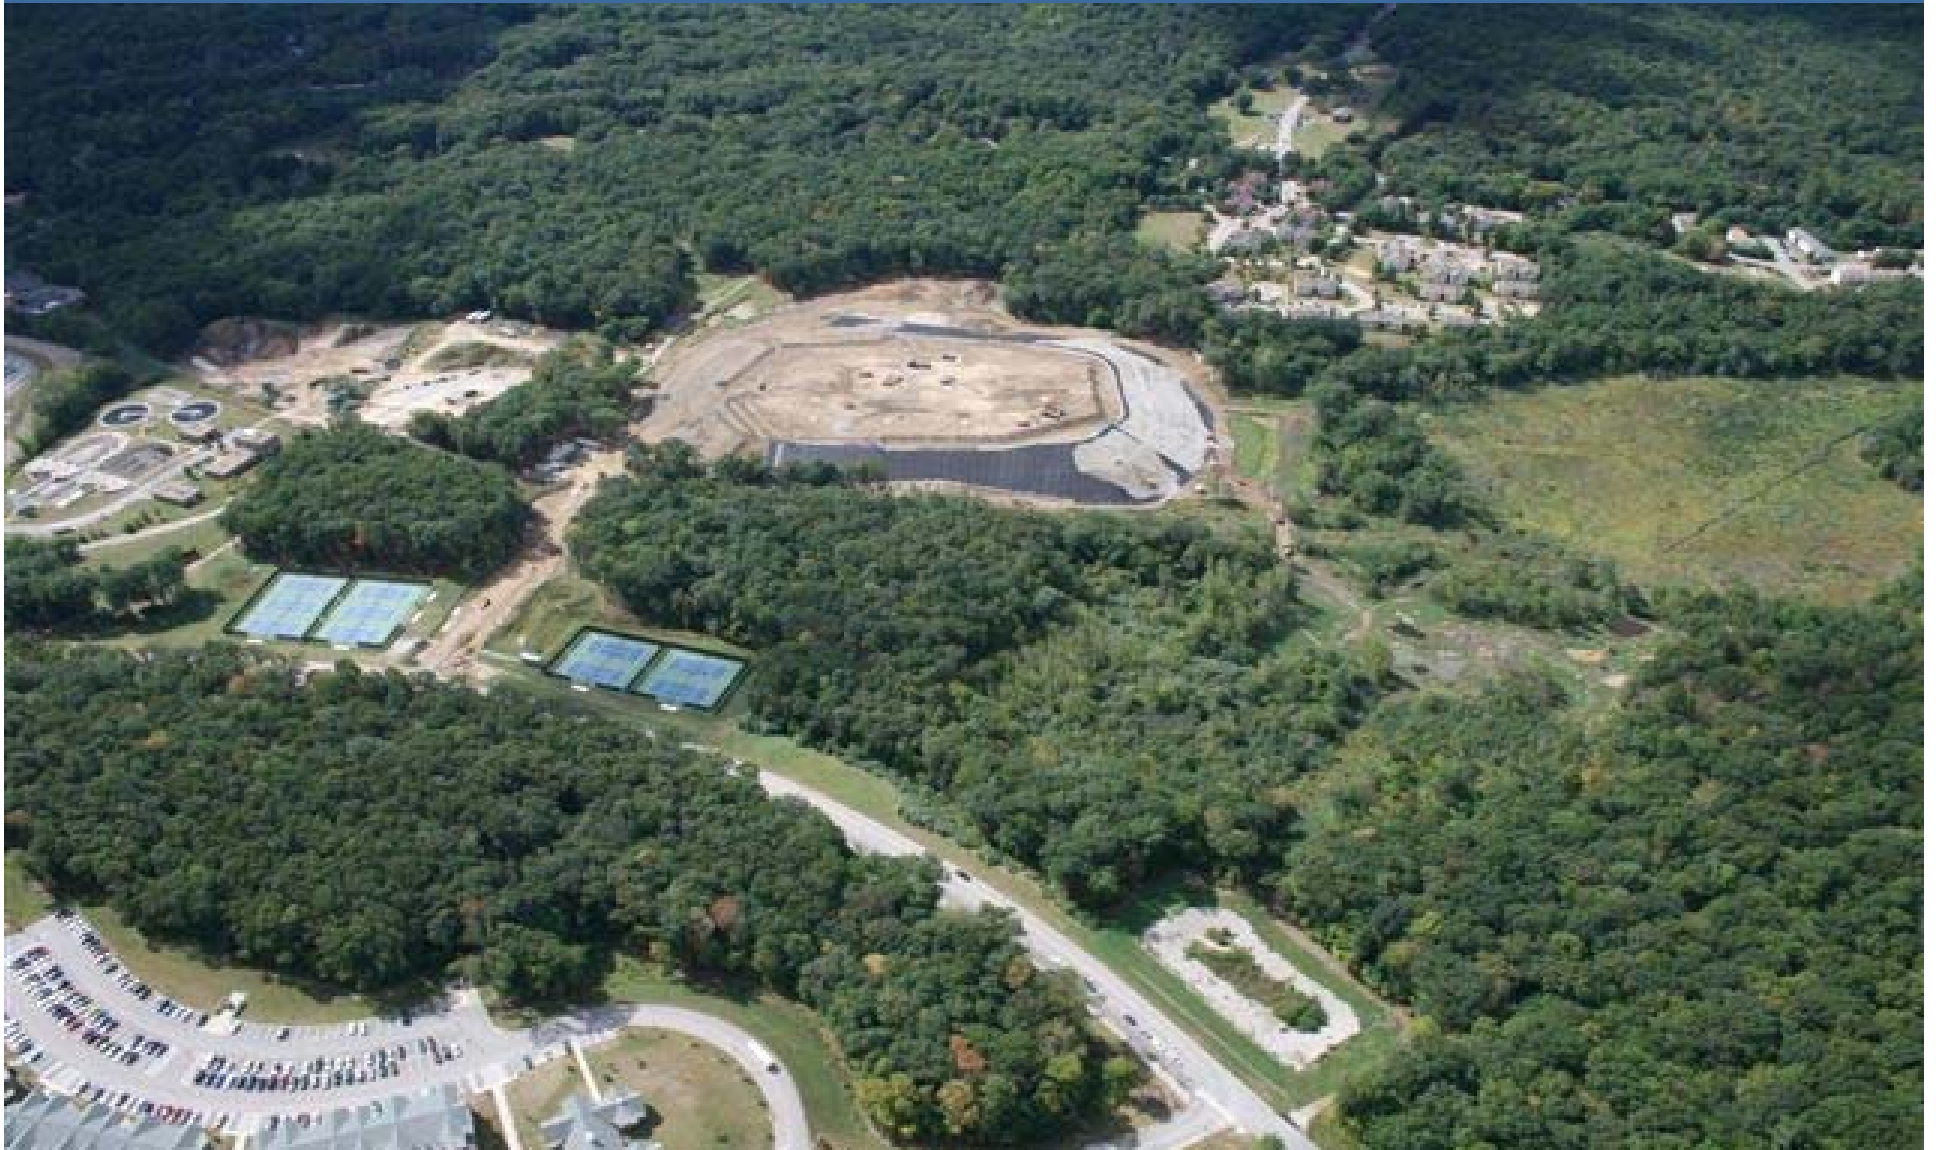
Remediation Strategy - Caps

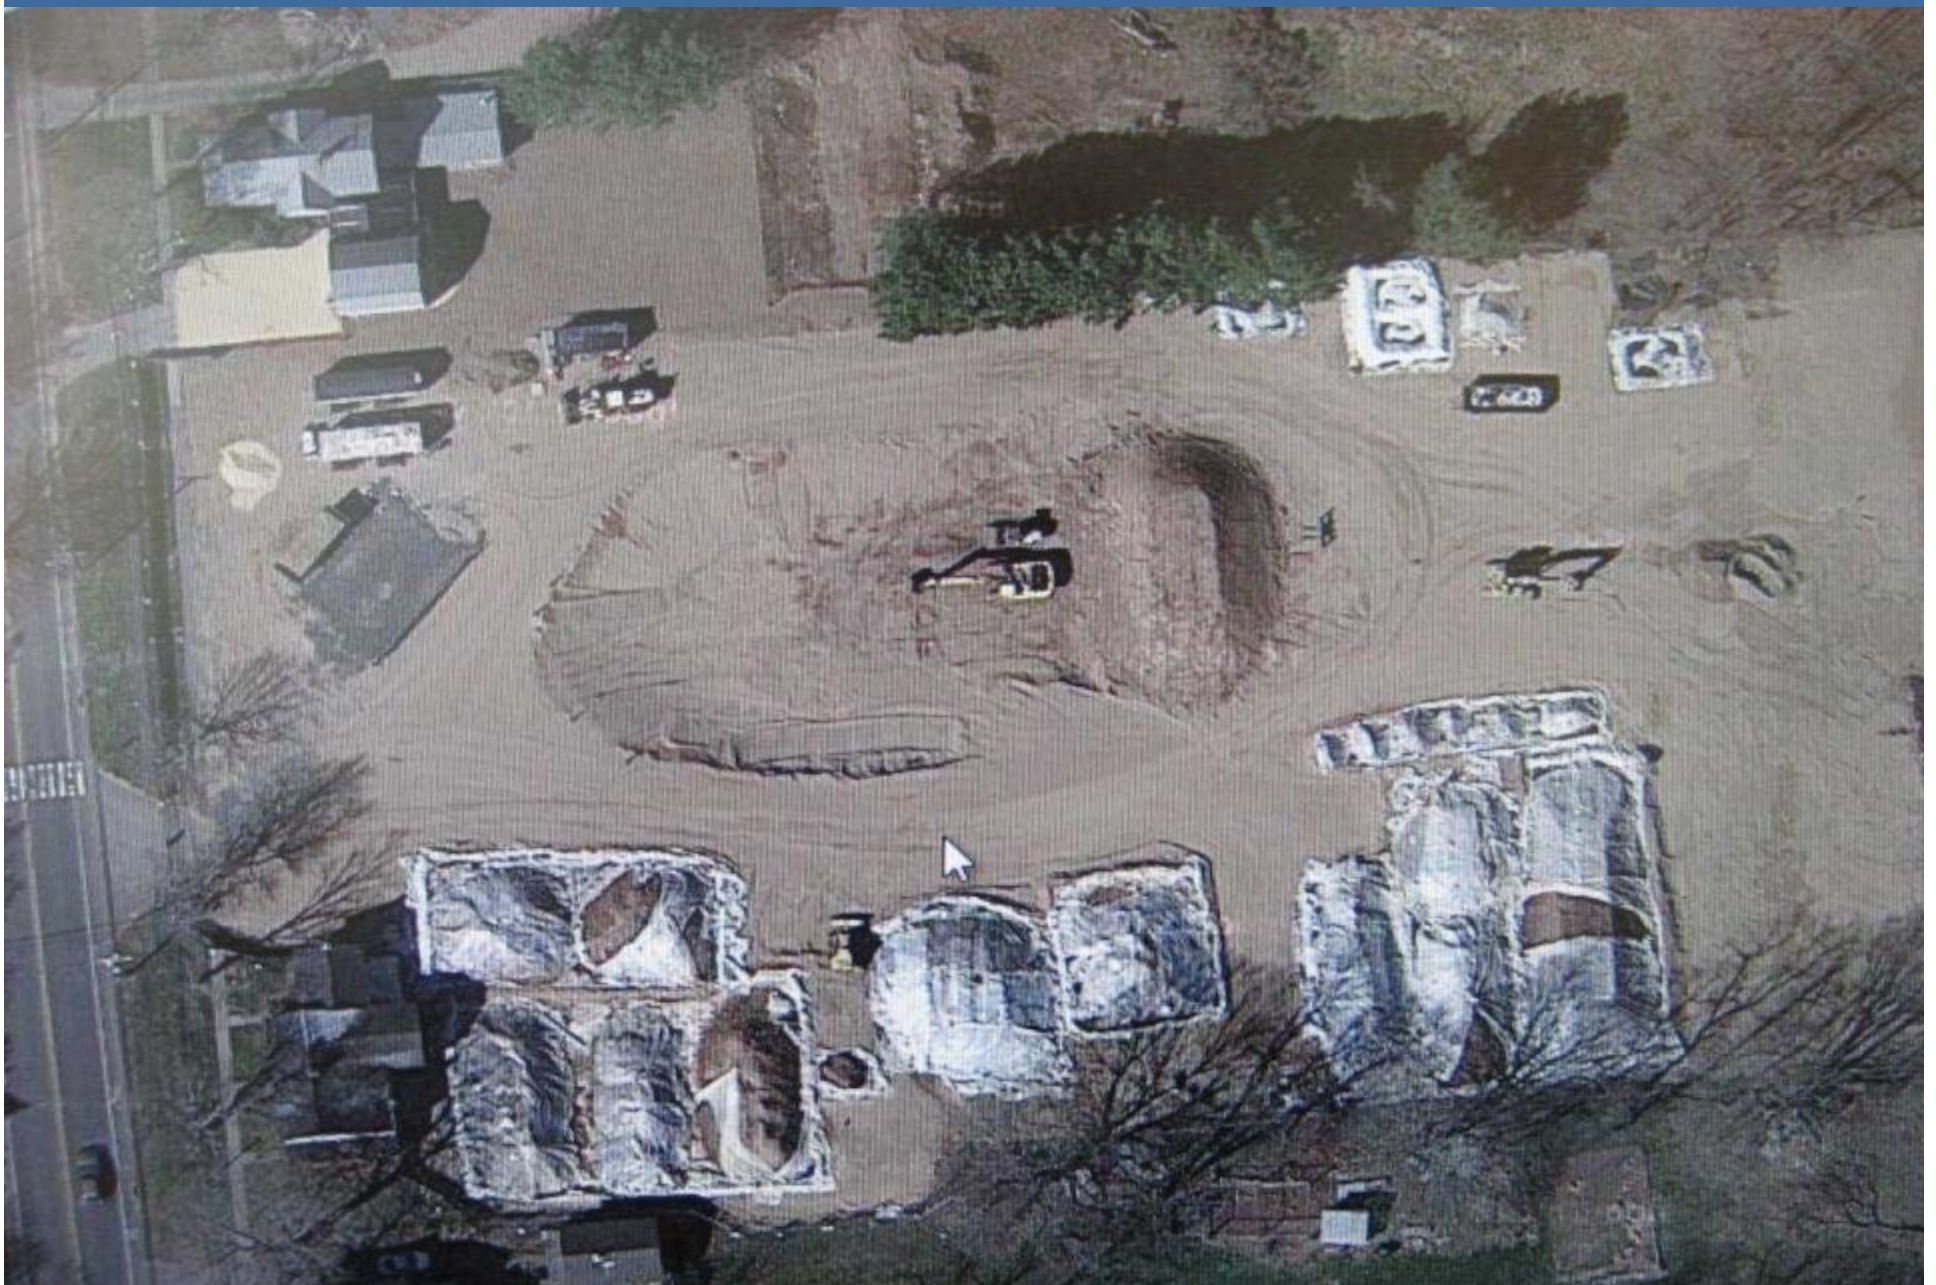
MMC – Remediation (from EPA)

- from 1851 – early 2000s
- The main portion of the factory Was destroyed by fire in 1998
- Soil was excavated by EPA

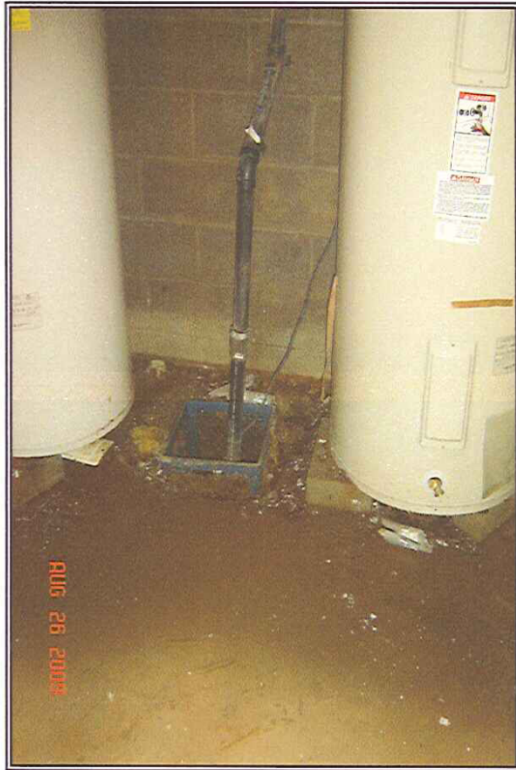
**Photograph 1: Building 2, Unit 38
- Previous Basement Sump**

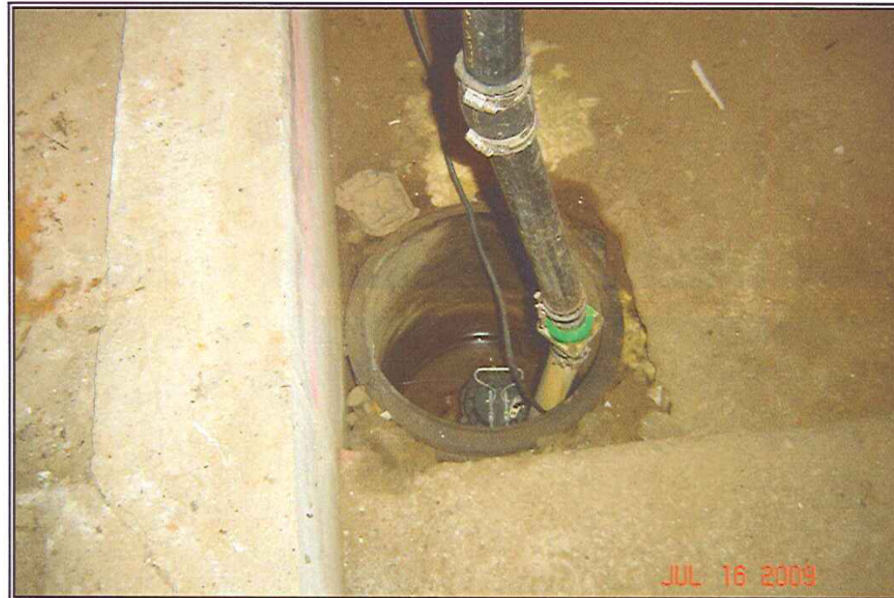
**Photograph 2: Building 3, Unit 43
- Previous Basement Sump**

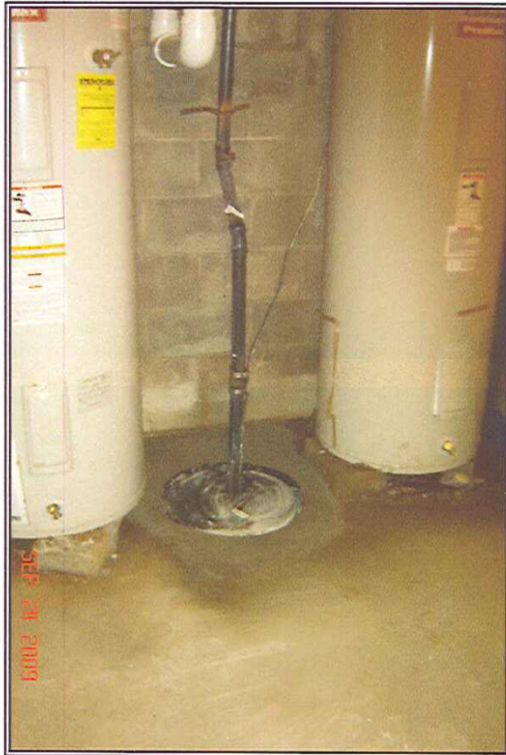
**Photograph 3: Building 2, Unit 38
- Typical Basement Radon Proof Sump**

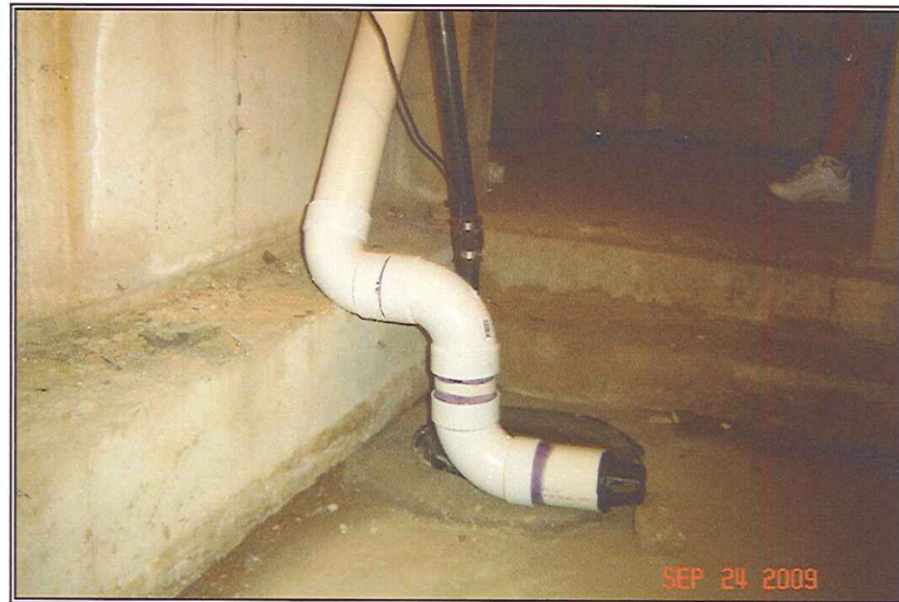
**Photograph 4: Building 4, Unit 45
- Basement Venting System Intake**

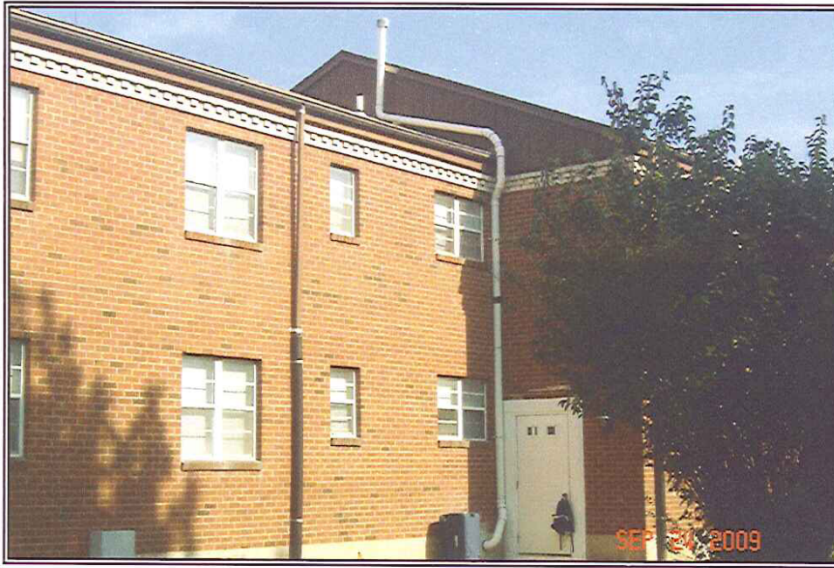
**Photograph 8: Building 4, Unit 46
- Basement Venting System**

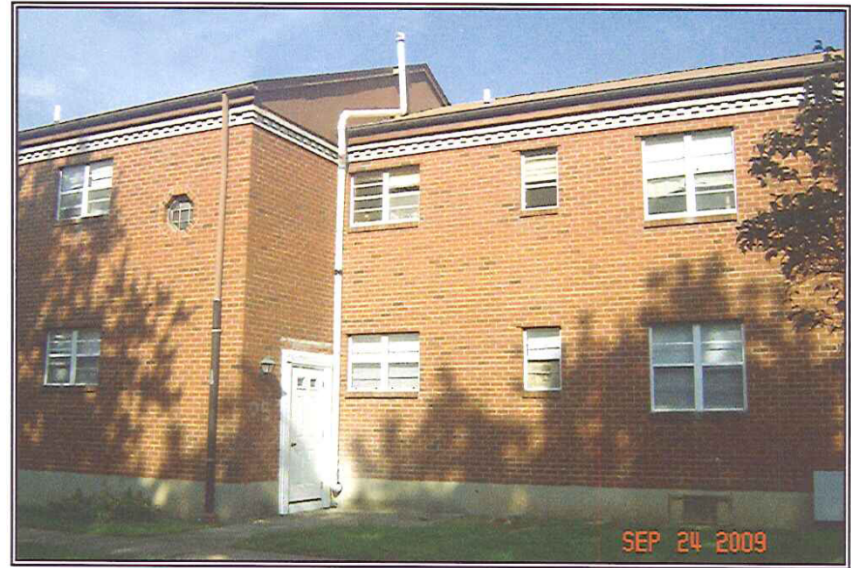
**Photograph 9: Building 4, Unit 45
- Basement Venting System**
