National Disaster Resilience and Rebuild by Design Projects
Bridgeport, Connecticut

**Final Environmental Impact Statement/
Environmental Impact Evaluation
APPENDICES**

Environmental Site Assessments

Task 110 Corridor Land Use Evaluation for the National Disaster Resilience Project

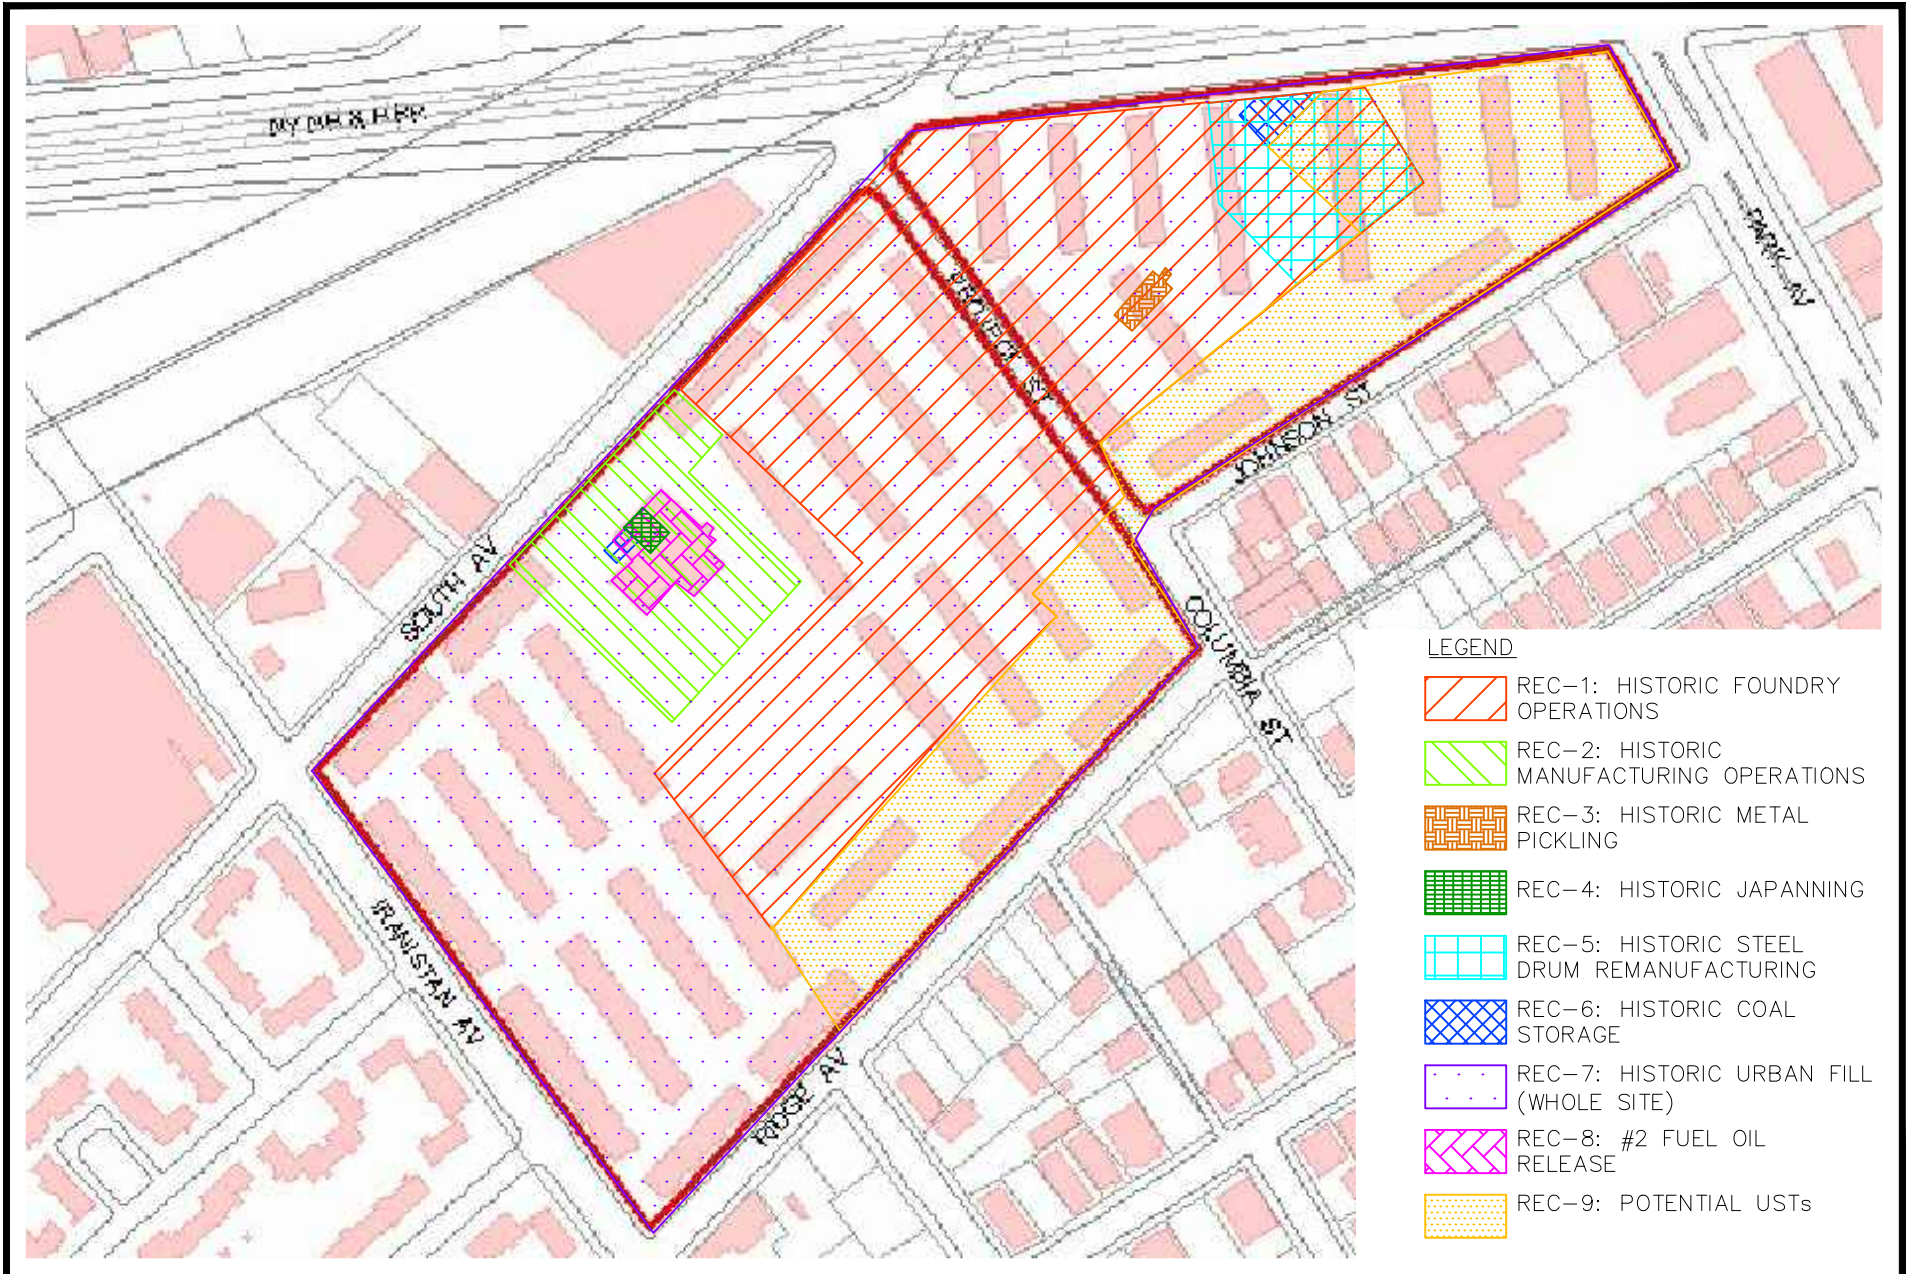
- LEGEND**
-   REC-1: HISTORIC FOUNDRY OPERATIONS
 -   REC-2: HISTORIC MANUFACTURING OPERATIONS
 -   REC-3: HISTORIC METAL PICKLING
 -   REC-4: HISTORIC JAPANING
 -   REC-5: HISTORIC STEEL DRUM REMANUFACTURING
 -   REC-6: HISTORIC COAL STORAGE
 -   REC-7: HISTORIC URBAN FILL (WHOLE SITE)
 -   REC-8: #2 FUEL OIL RELEASE
 -   REC-9: POTENTIAL USTs

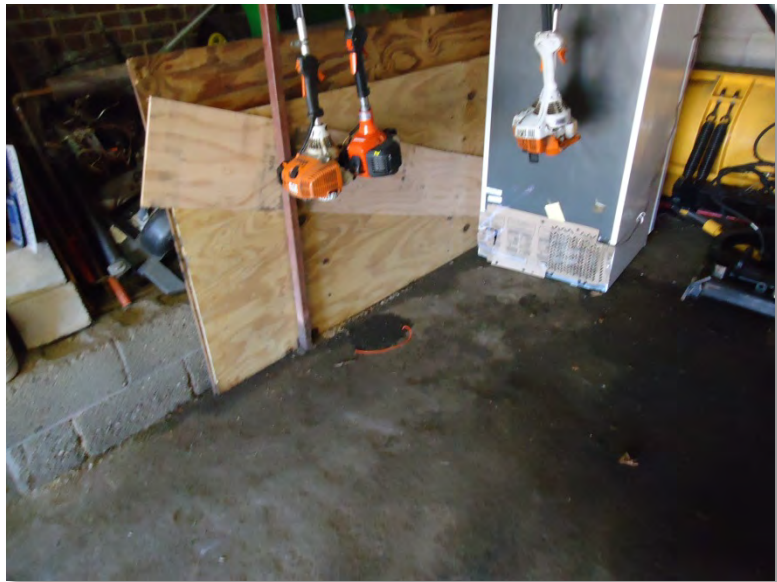
Photo 4: Minor staining below lawn equipment in the maintenance garage.

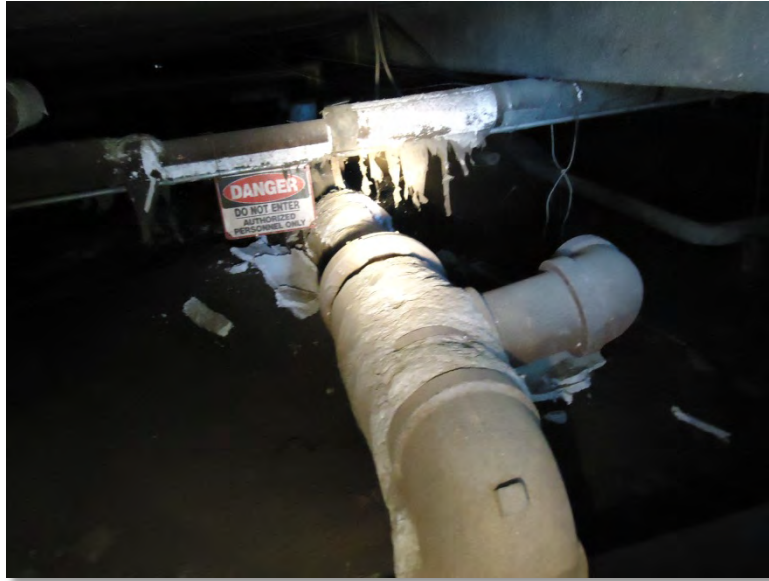
Photo 5: Potential asbestos containing pipe insulation in crawl space of apartment building.

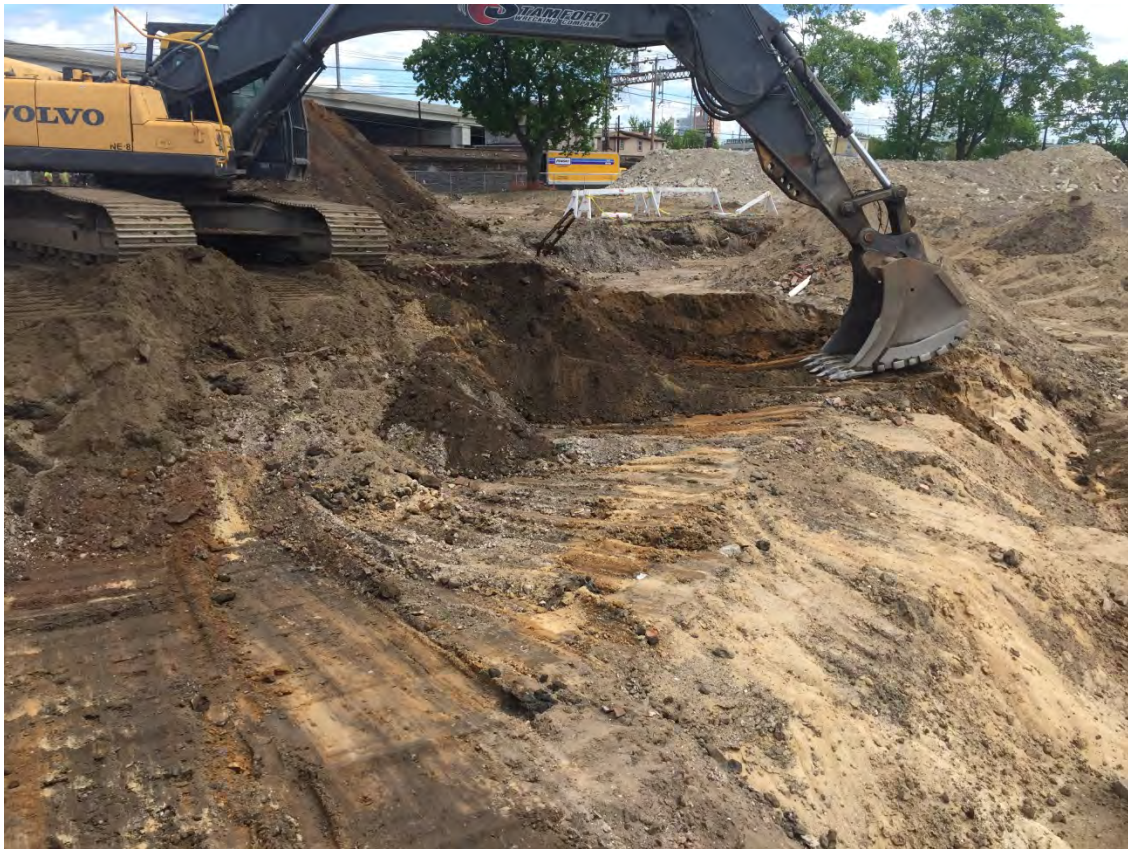
Photo 1: Excavation activities

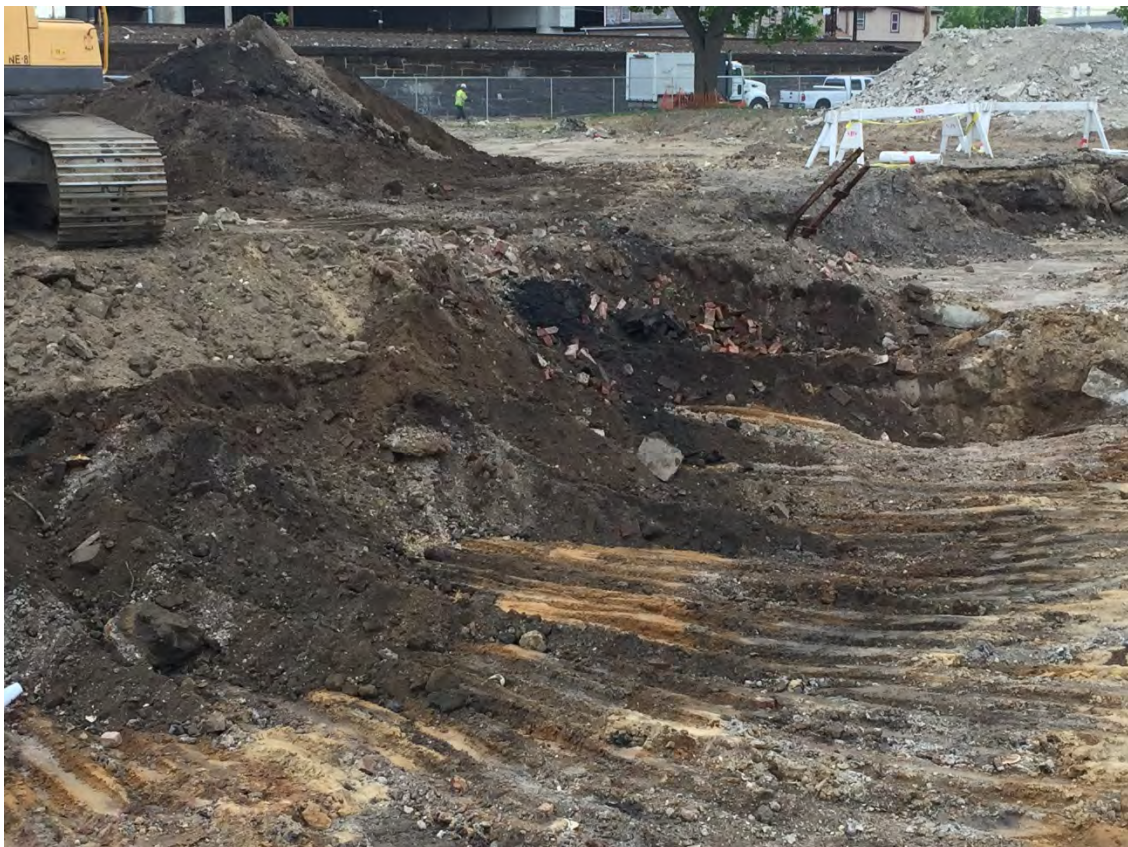
Photo 2: Removal of ash material

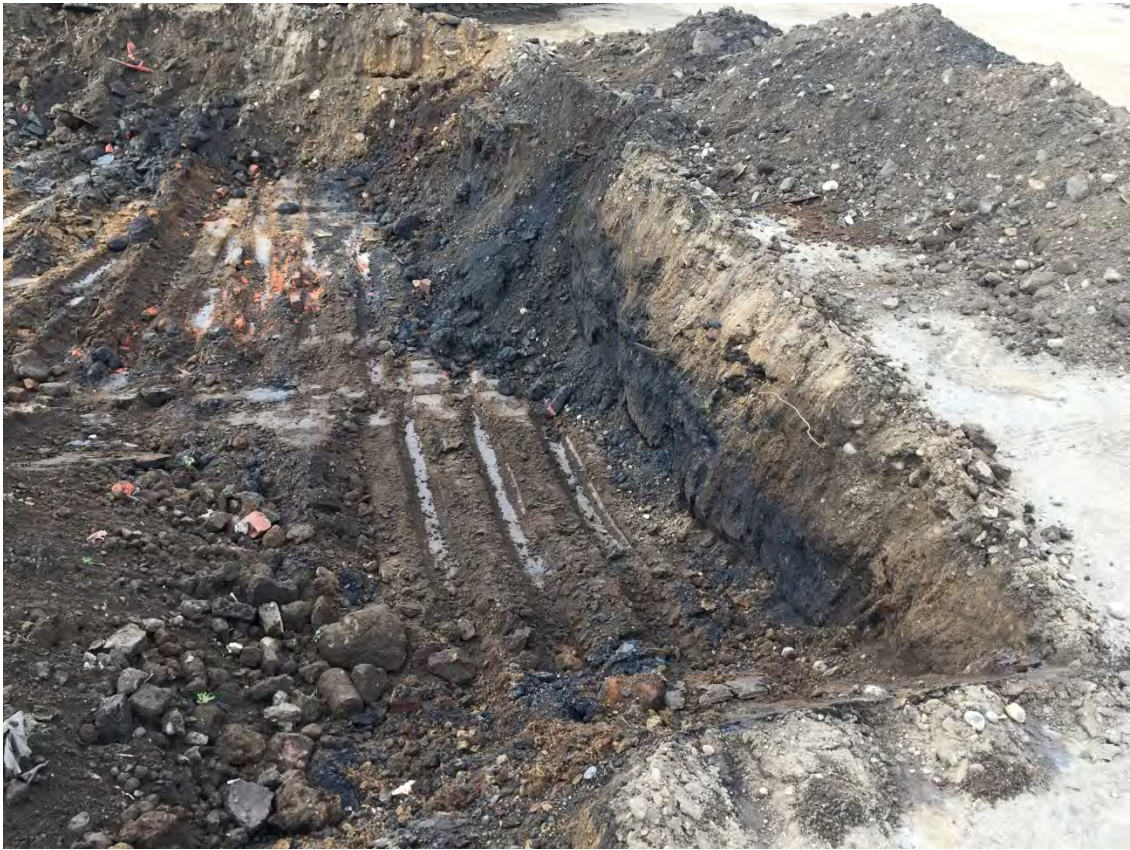
Photo 3: Removal of material from coal storage area

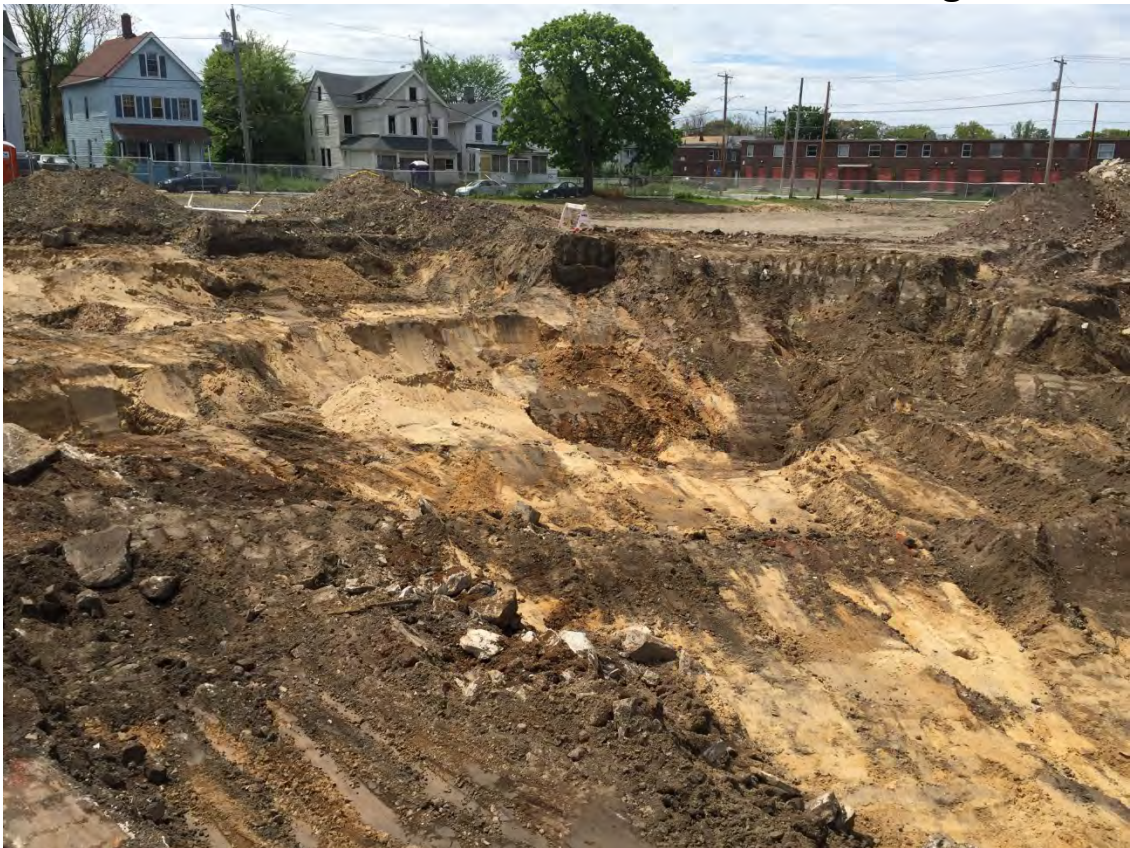
Photo 4: Clean sand remaining after removal of impacted material

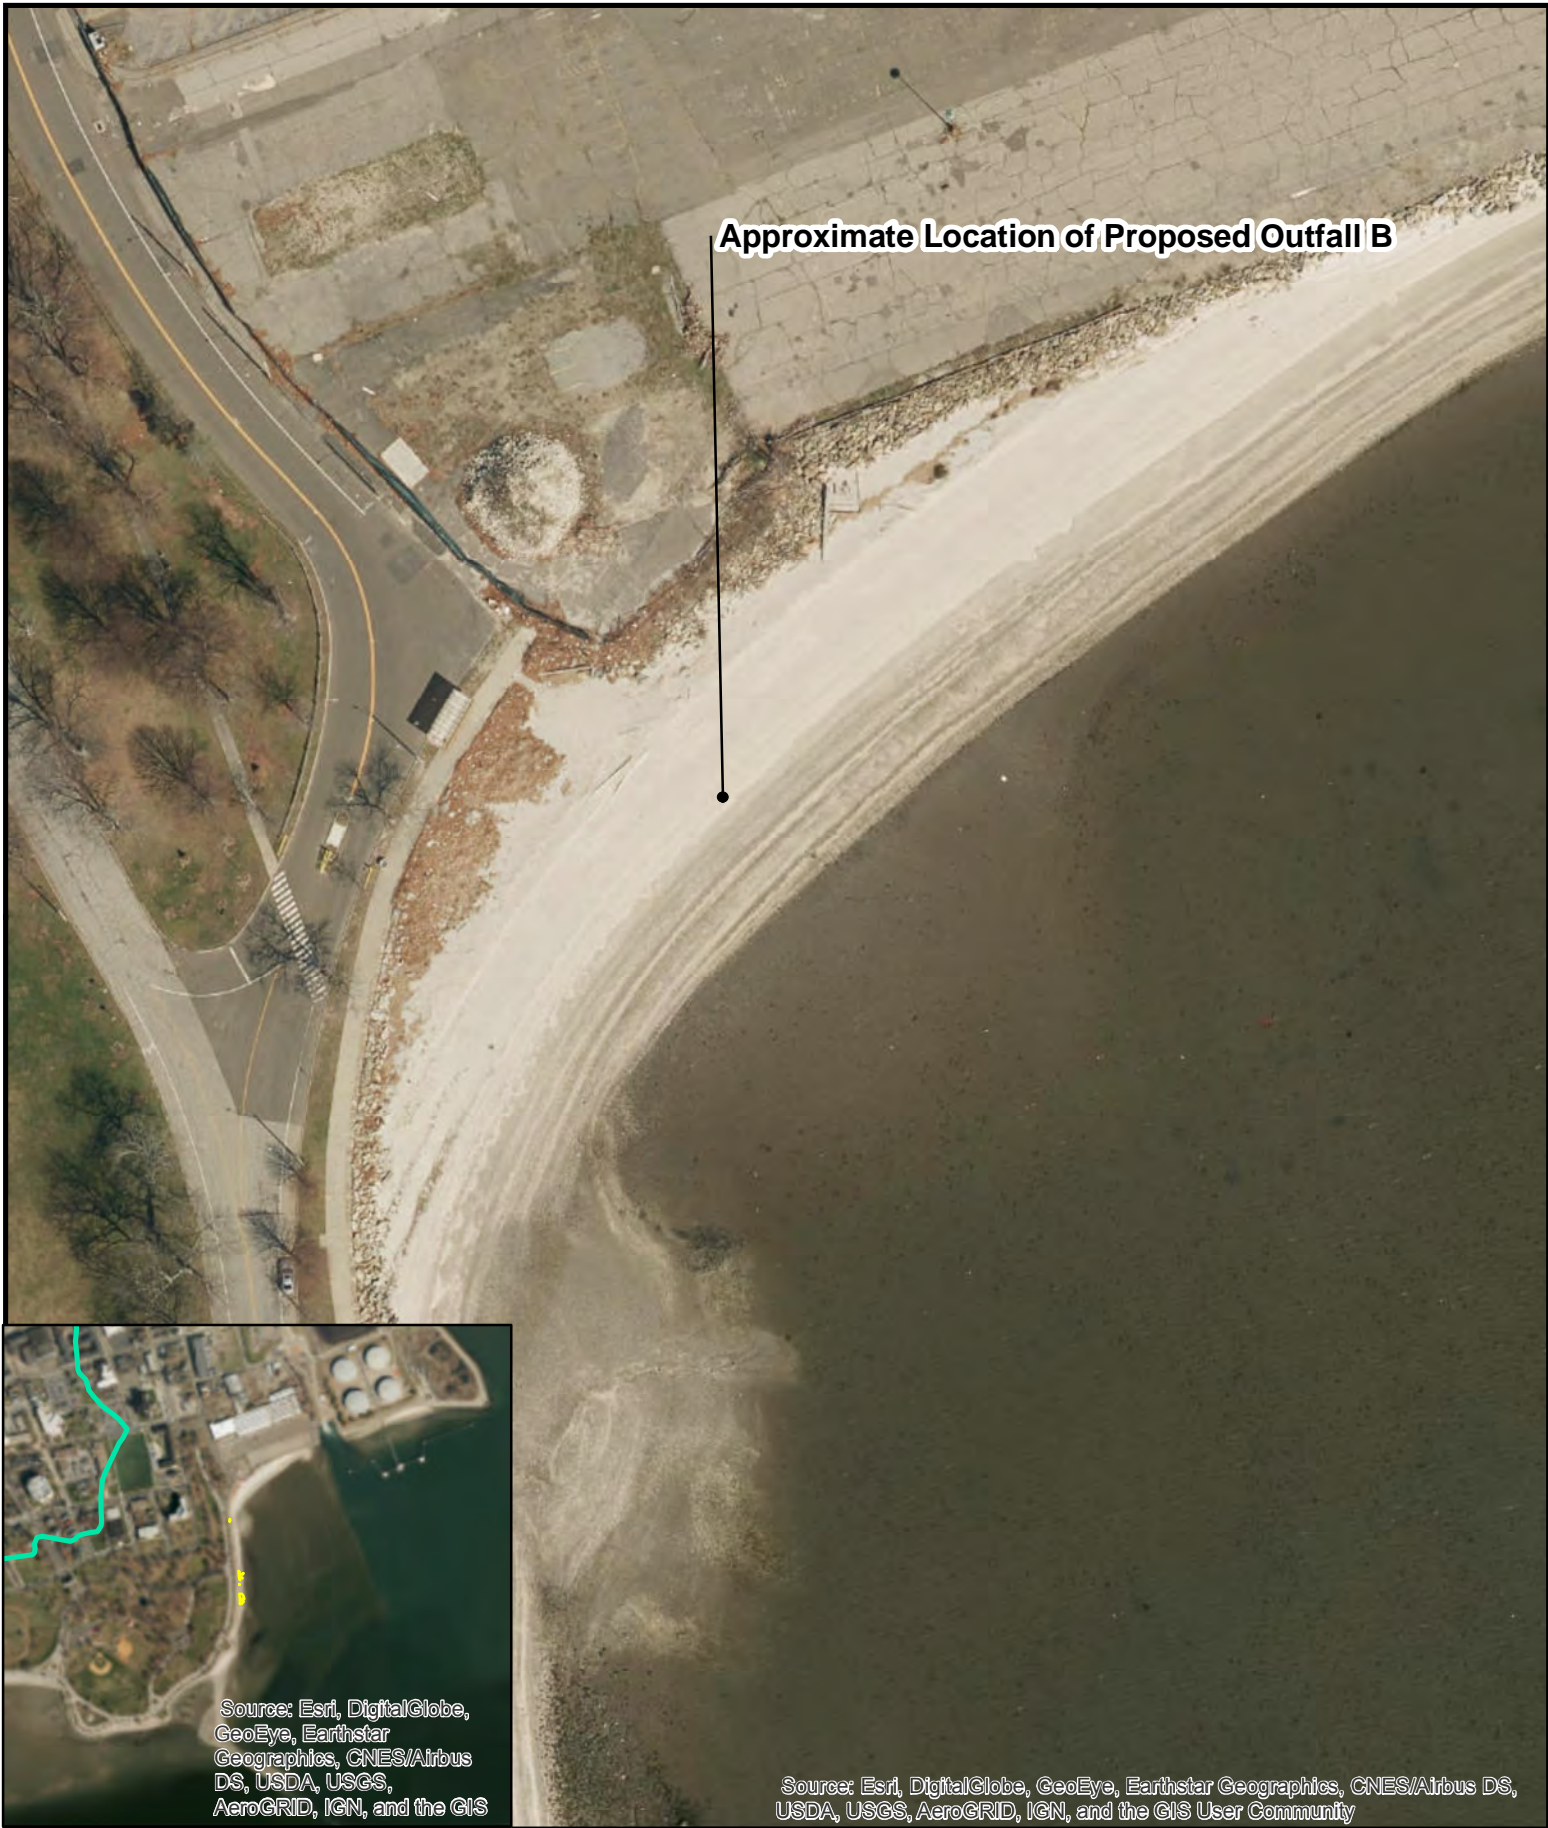
Figure 2: Proposed Outfall B

Approximate Location of Proposed Outfall B

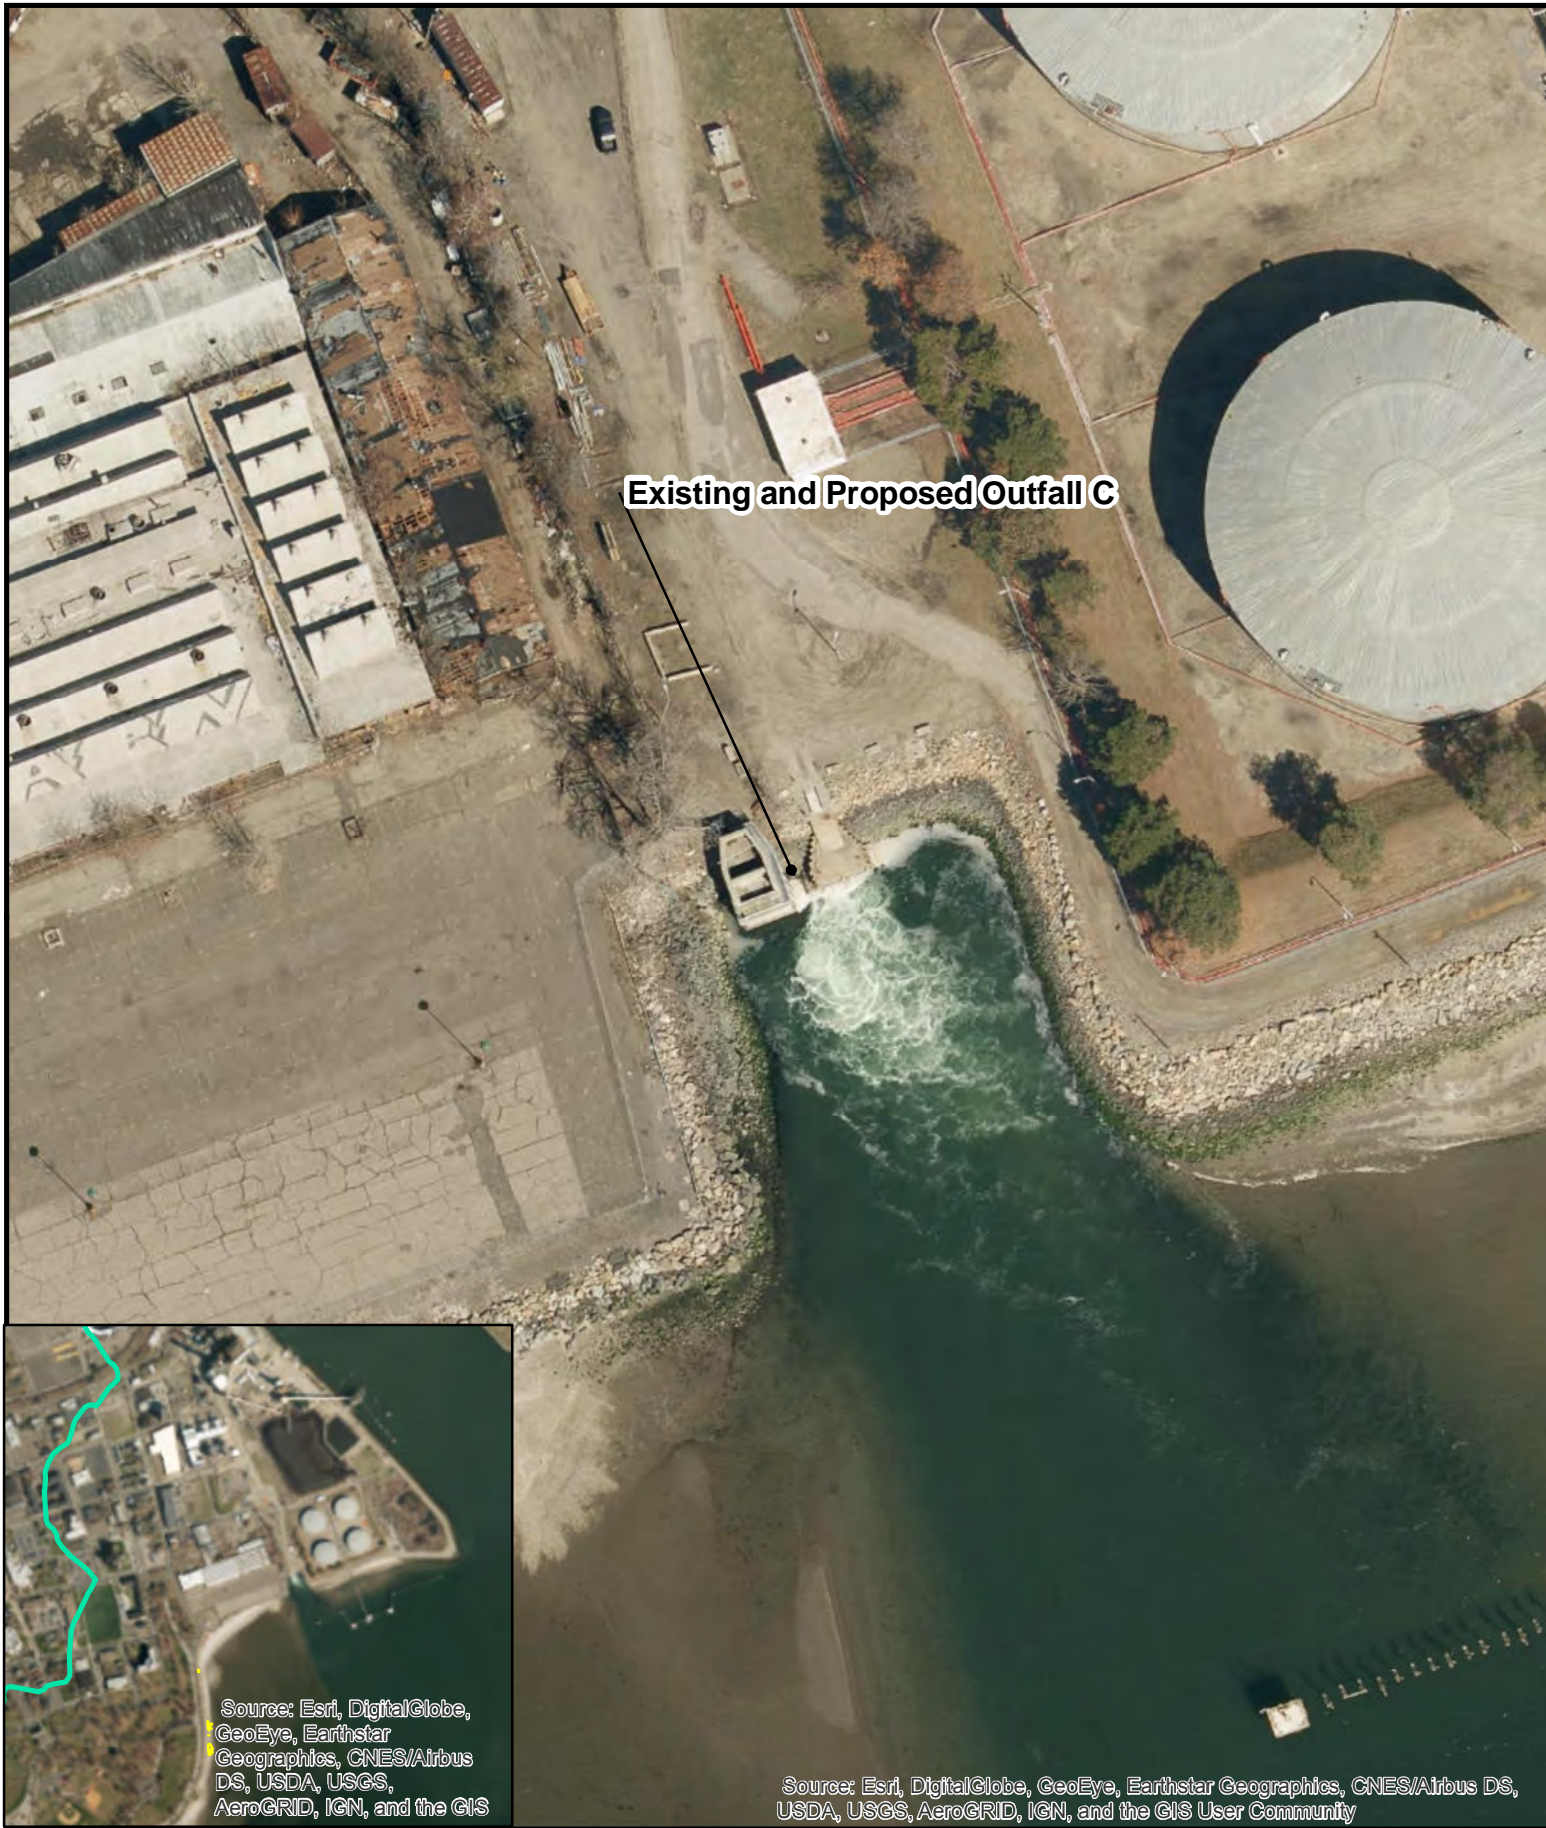
Figure 3: Proposed Outfall C

Existing and Proposed Outfall C

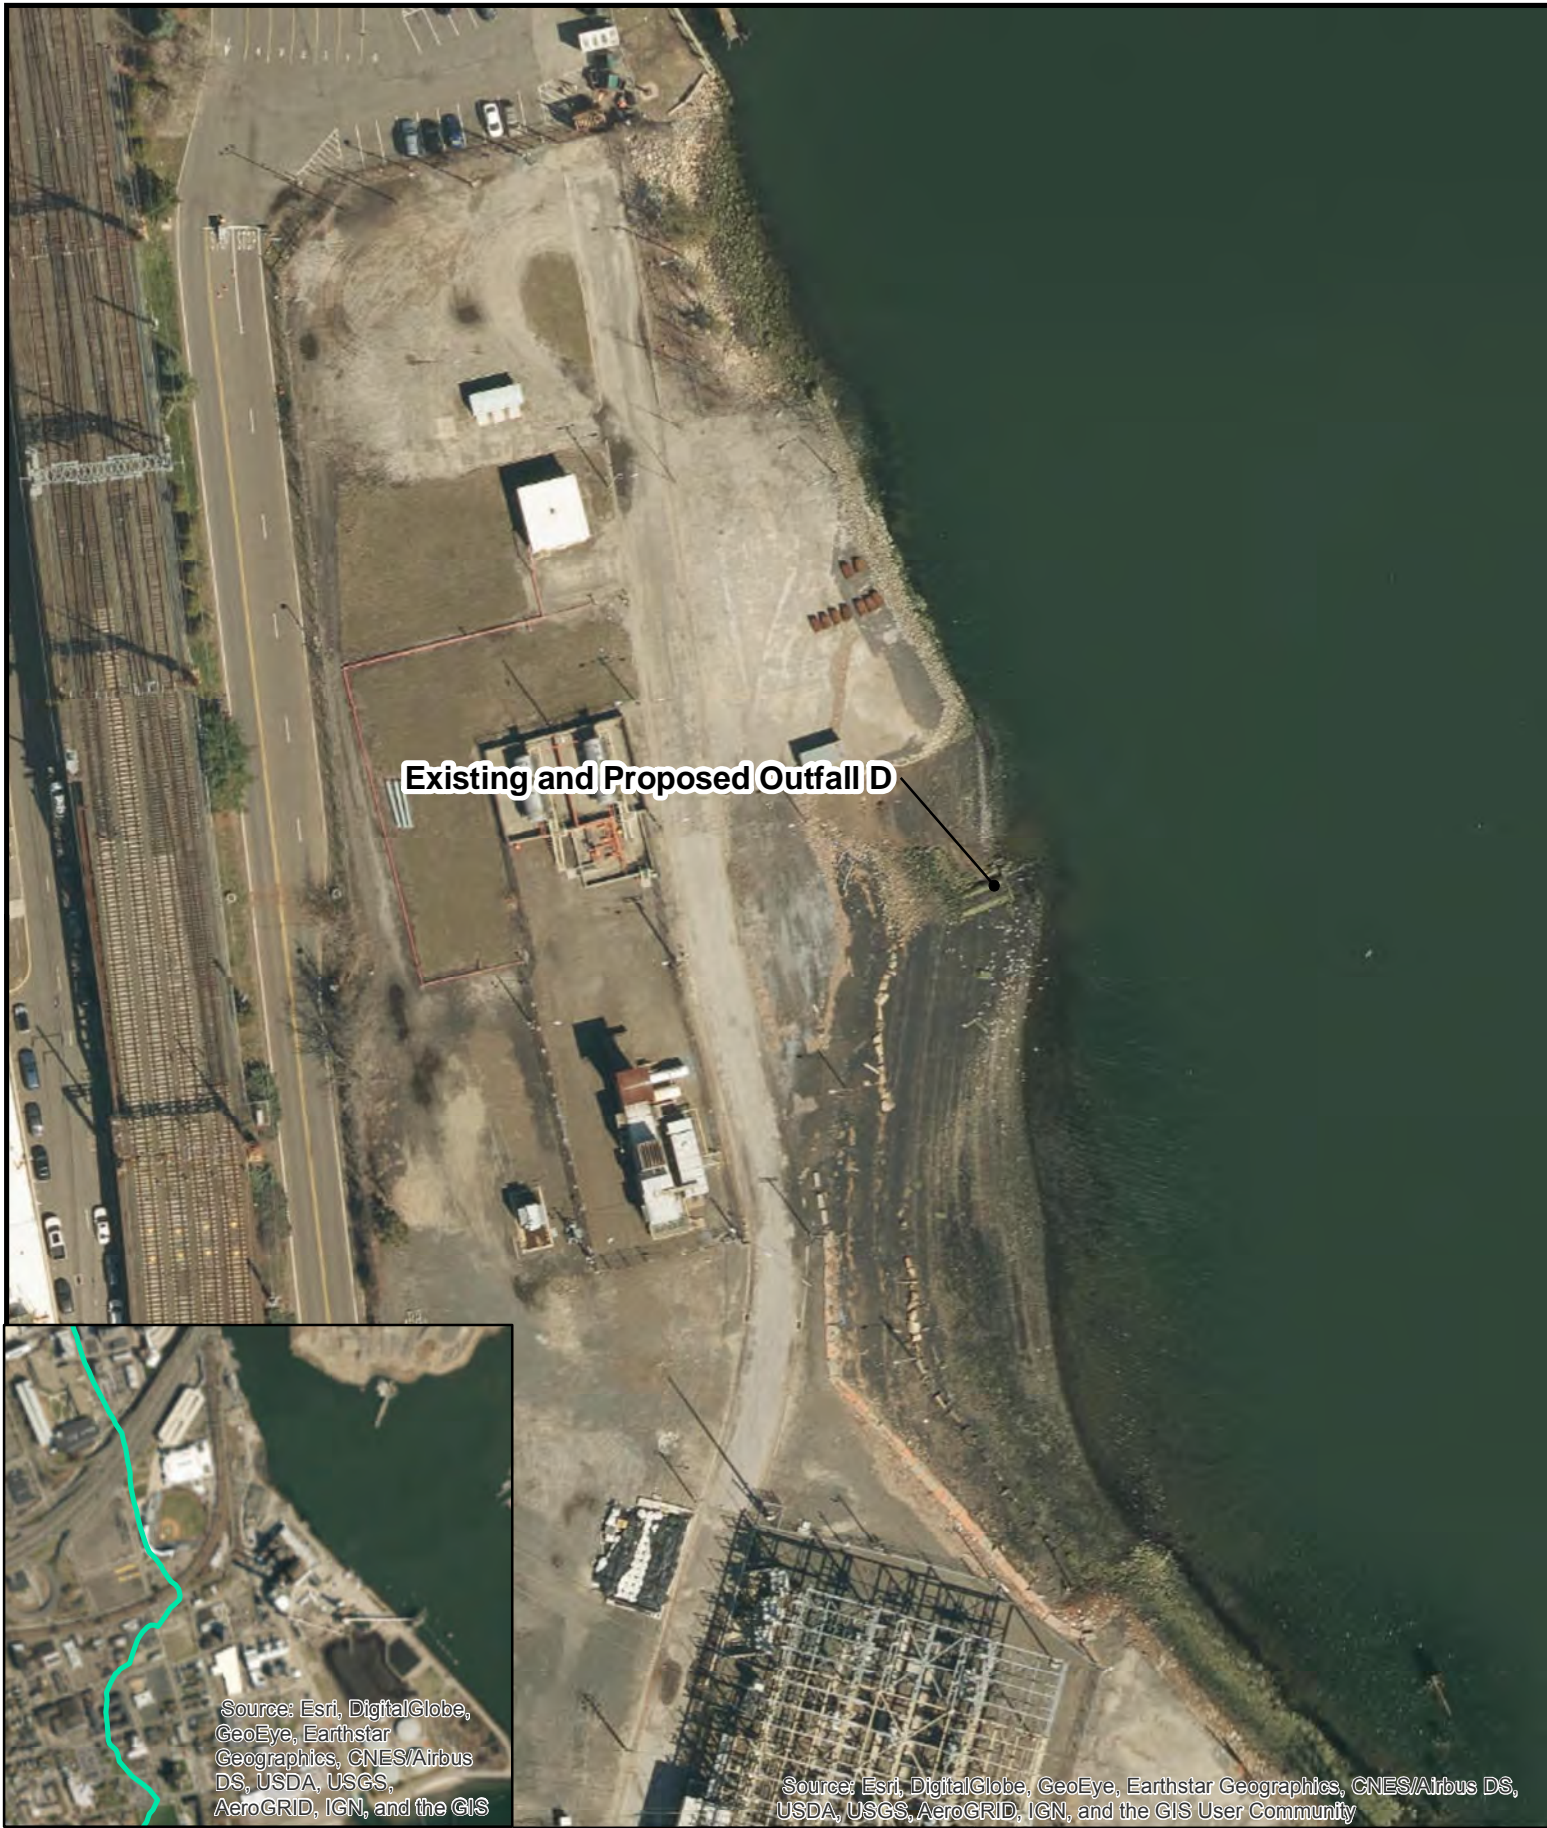
Figure 4: Proposed Outfall D

Existing and Proposed Outfall D

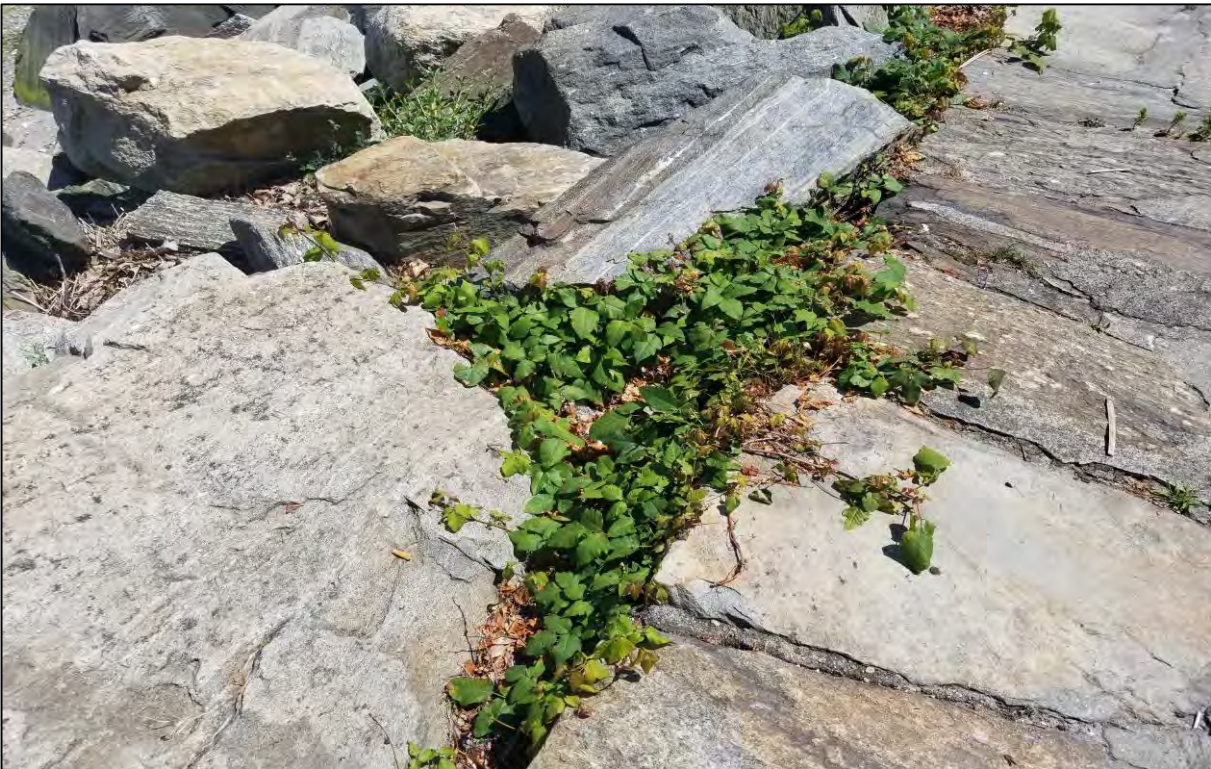
PHOTO 2: View of small patch of tidal vegetation (*Toxicodendron radicans*) in the vicinity of Outfall A, growing between the boulder revetment and the sidewalk.

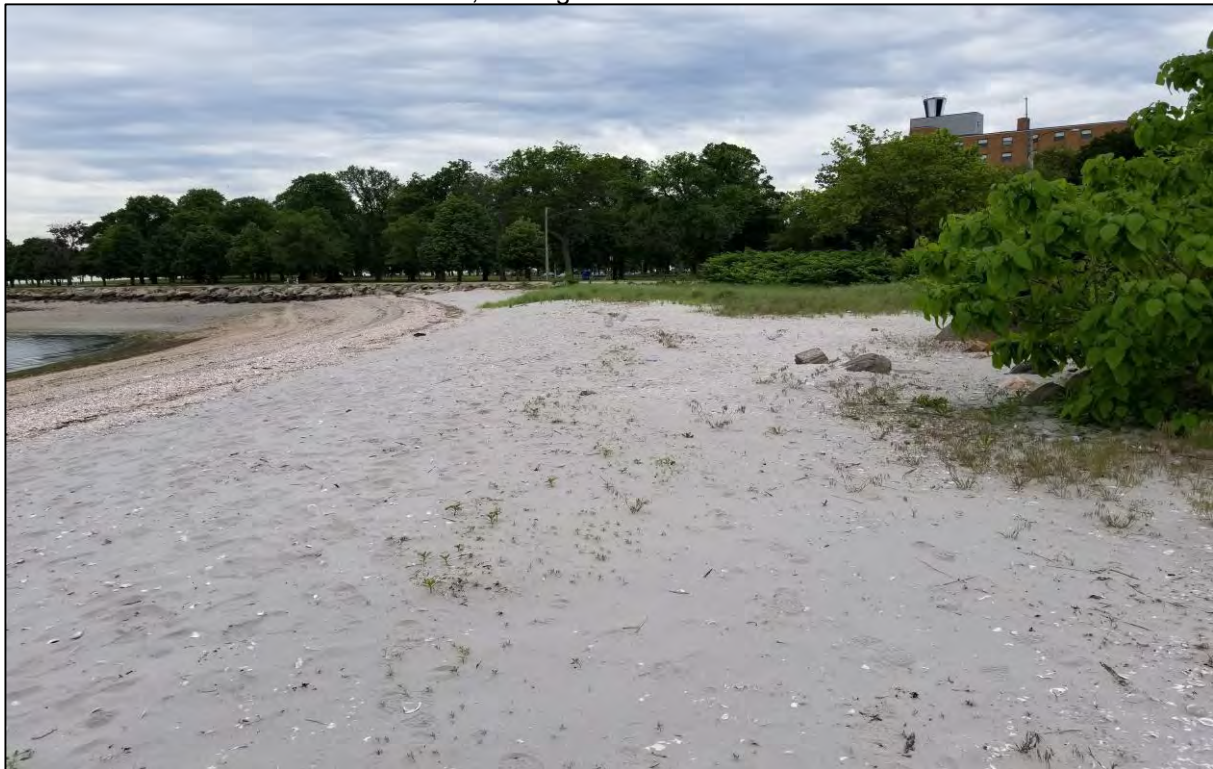
PHOTO 4: View of approximate location of proposed Outfall B. Vegetation is present, but not considered tidal.

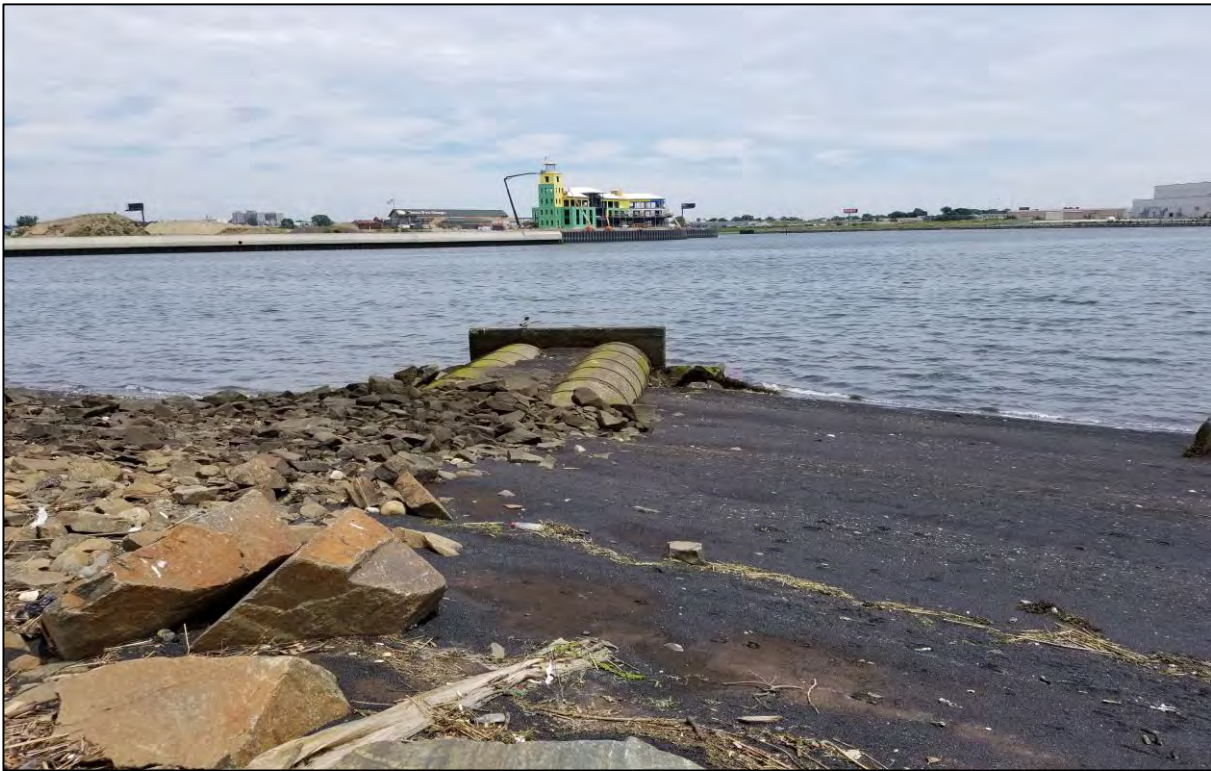
PHOTO 6: Existing Outfall D, looking east towards Bridgeport Harbor.

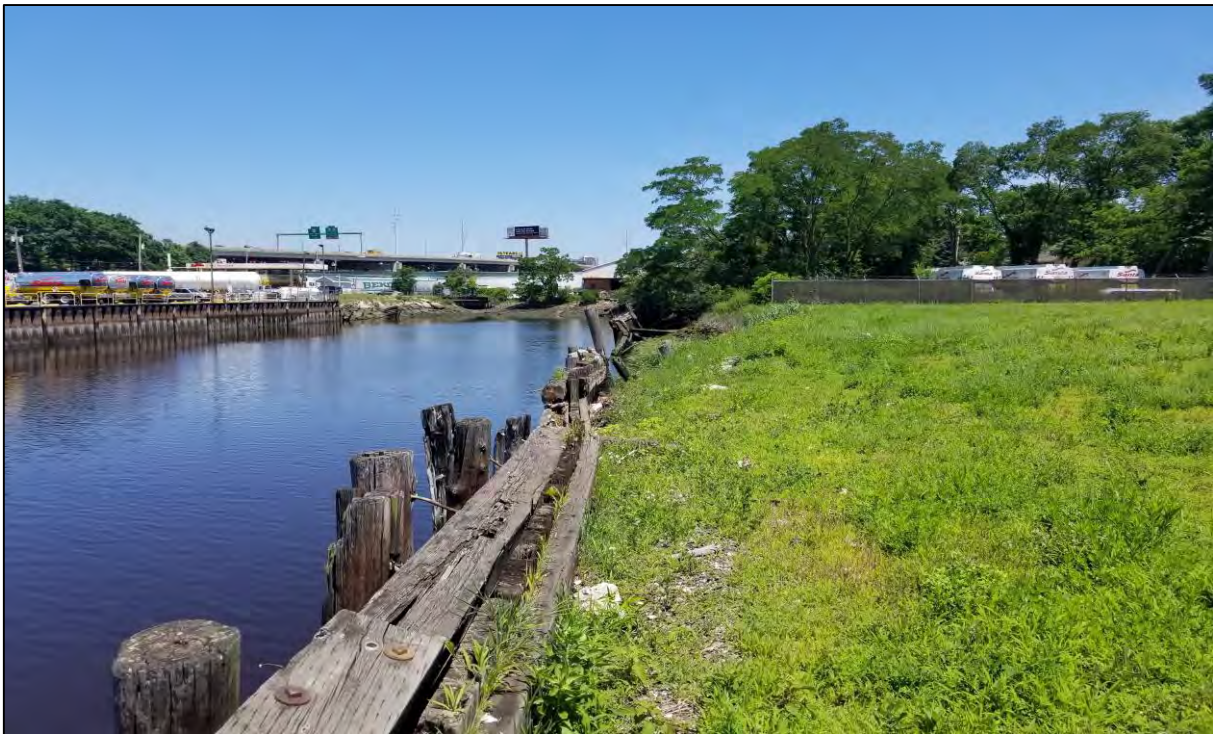
PHOTO 7: View of timber retaining wall along the approximate location of proposed Outfall E.

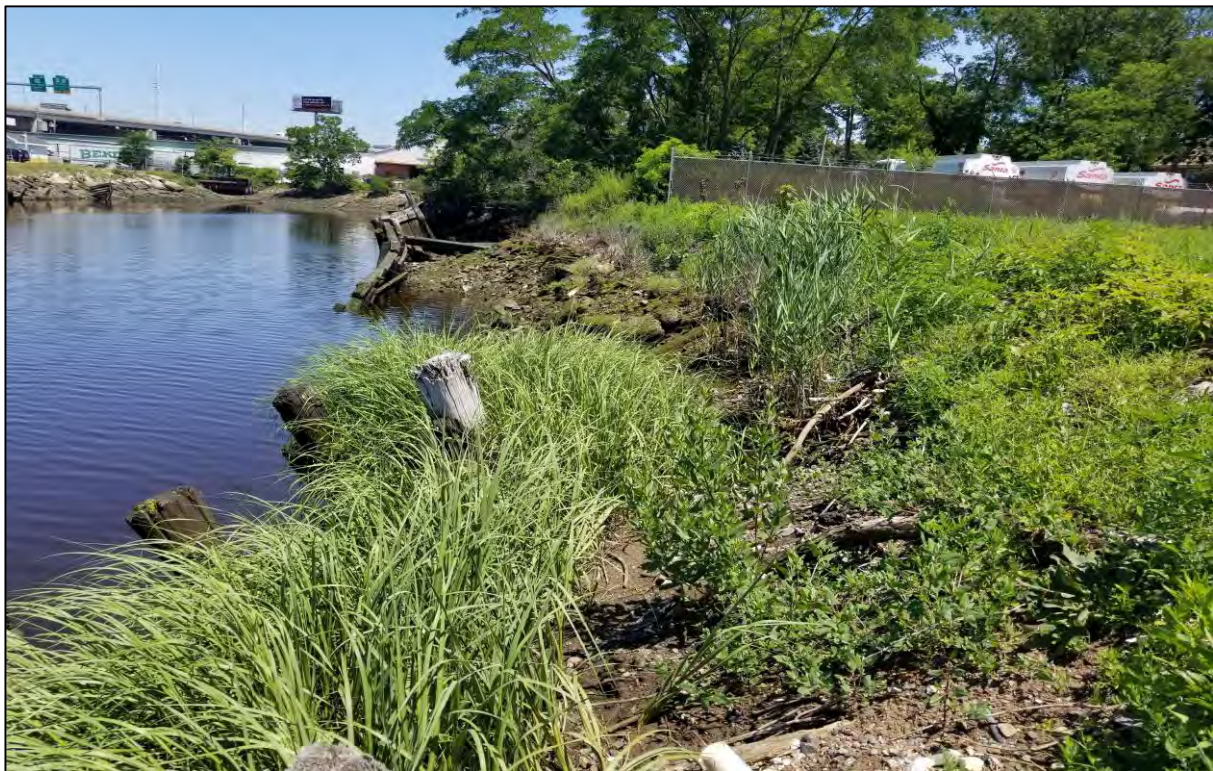
PHOTO 8: View of tidal vegetation (*S. alterniflora*, *Iva frutescens*, *Baccharis halmifolia*) along the collapsed portion of the timber retaining wall in the vicinity of proposed Outfall E.

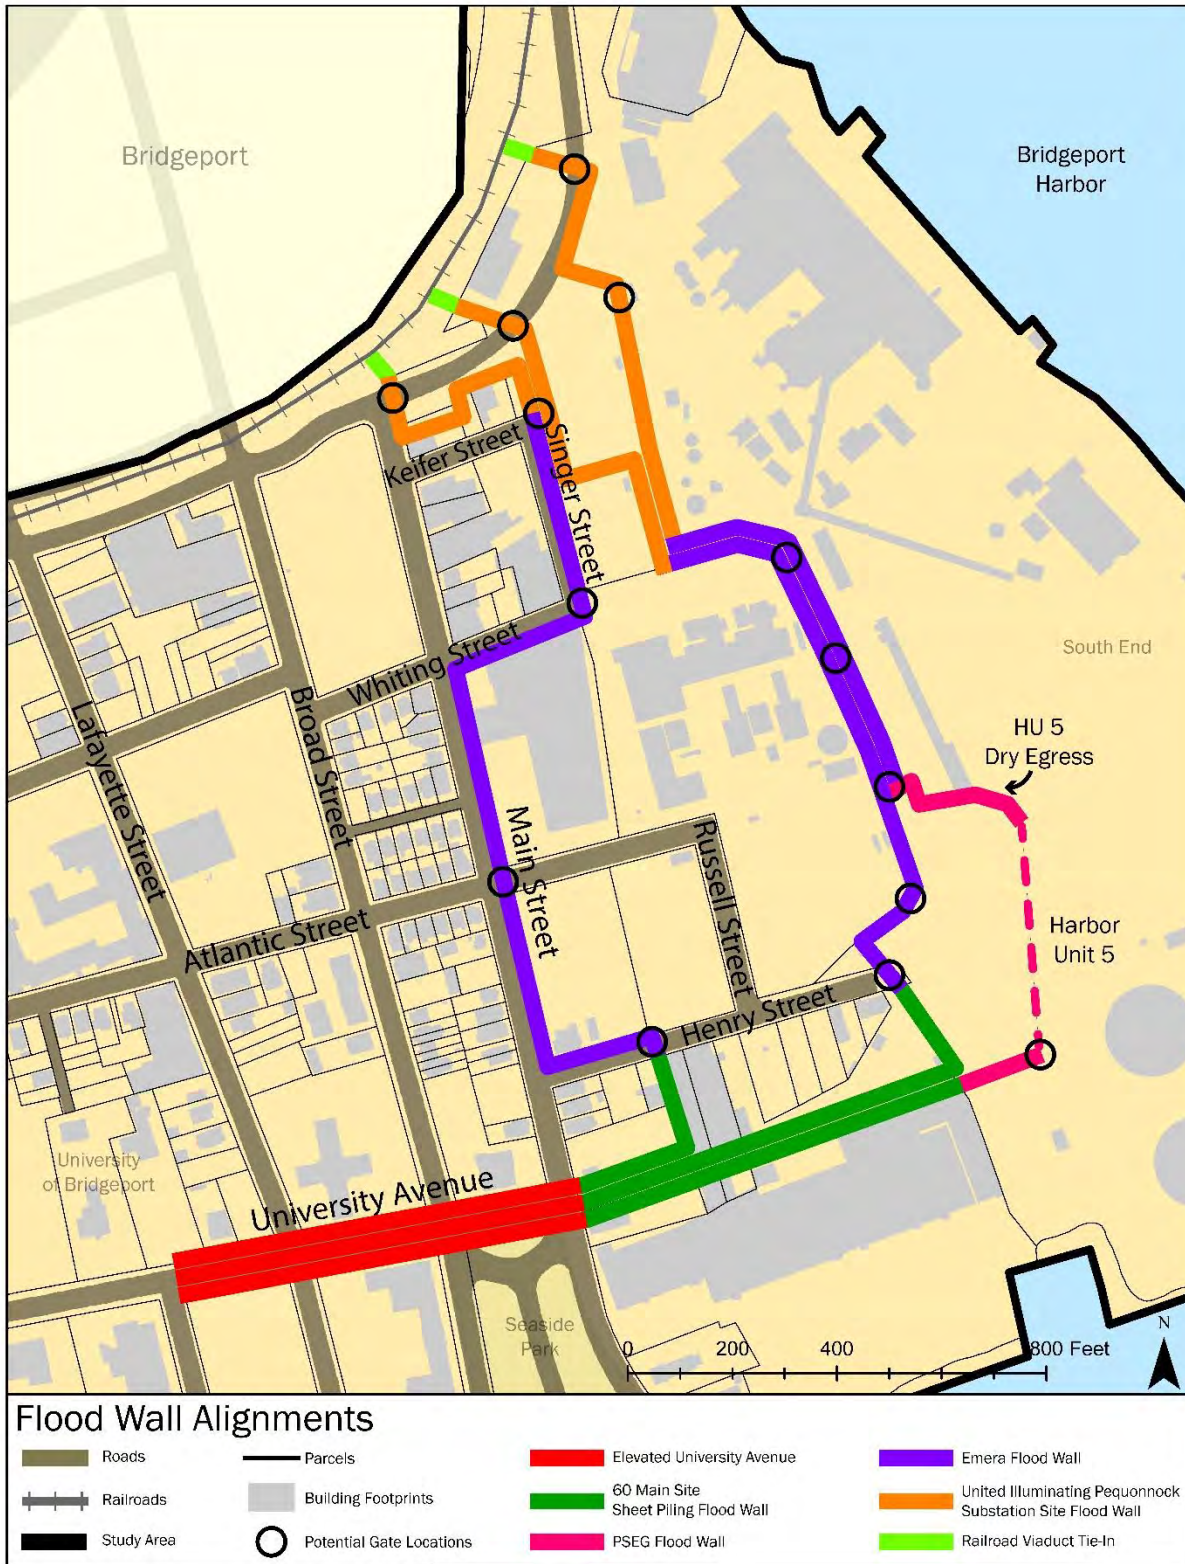
Figure 1 - Preliminary Coastal Defense System Alignments

The EIS includes both the Resilient Bridgeport NDR and RBD projects. This traffic assessment is developed to support the EIS and includes the NDR project only with RBD analyzed in a separate report. The NDR project includes a combination of measures in the eastern South End of Bridgeport, CT to reduce the flood risk within the project area from current and future coastal surge and chronic rainfall events. The measures would include constructing a coastal defense system (CDS) consisting of raising a portion of University Avenue, installing floodwalls connecting to high ground, and implementing stormwater and internal drainage management strategies (e.g., detention/retention features, drainage structures, and pump systems). The Project Team is currently evaluating alternatives for the location of the CDS, which is expected to include the eastern end of University Avenue, portions of the 60 Main Street Development and north-south corridor located somewhere between Main Street and the western edge of PSEG's property, terminating at the Metro North Rail Line north of Ferry Access Rd as shown in Figure 1.
