National Disaster Resilience and Rebuild by Design Projects
Bridgeport, Connecticut

**Final Environmental Impact Statement/
Environmental Impact Evaluation
APPENDICES**

Environmental Site Assessments

Task 110 Corridor Land Use Evaluation for the National Disaster Resilience Project

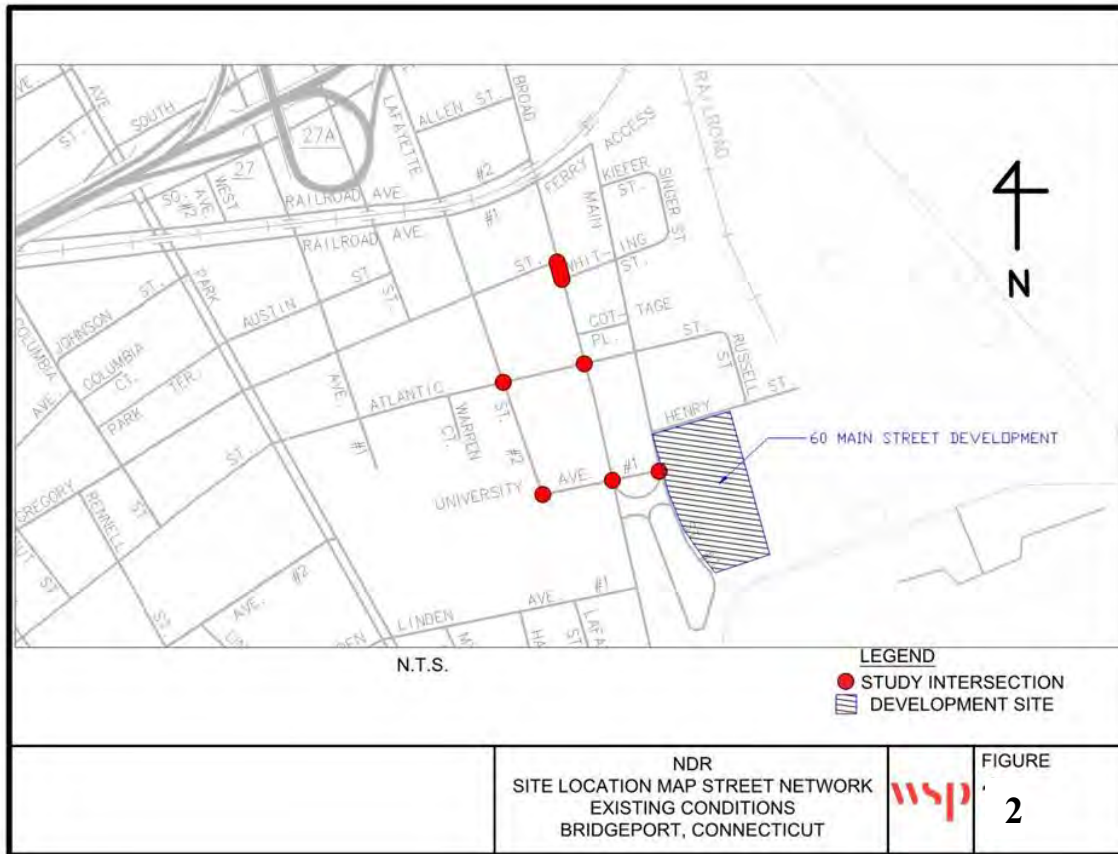
Figure 2 - Study Area Intersections and Roadway Network

1. University Avenue at Lafayette Street
2. University Avenue at Broad Street
3. University Avenue at Main Street (including Soundview Circle at Main Street)
4. Atlantic Street at Lafayette Street
5. Atlantic Street at Broad Street
6. Gregory Street (Bishop JC White Boulevard) at Broad Street (including Whiting Street approach)

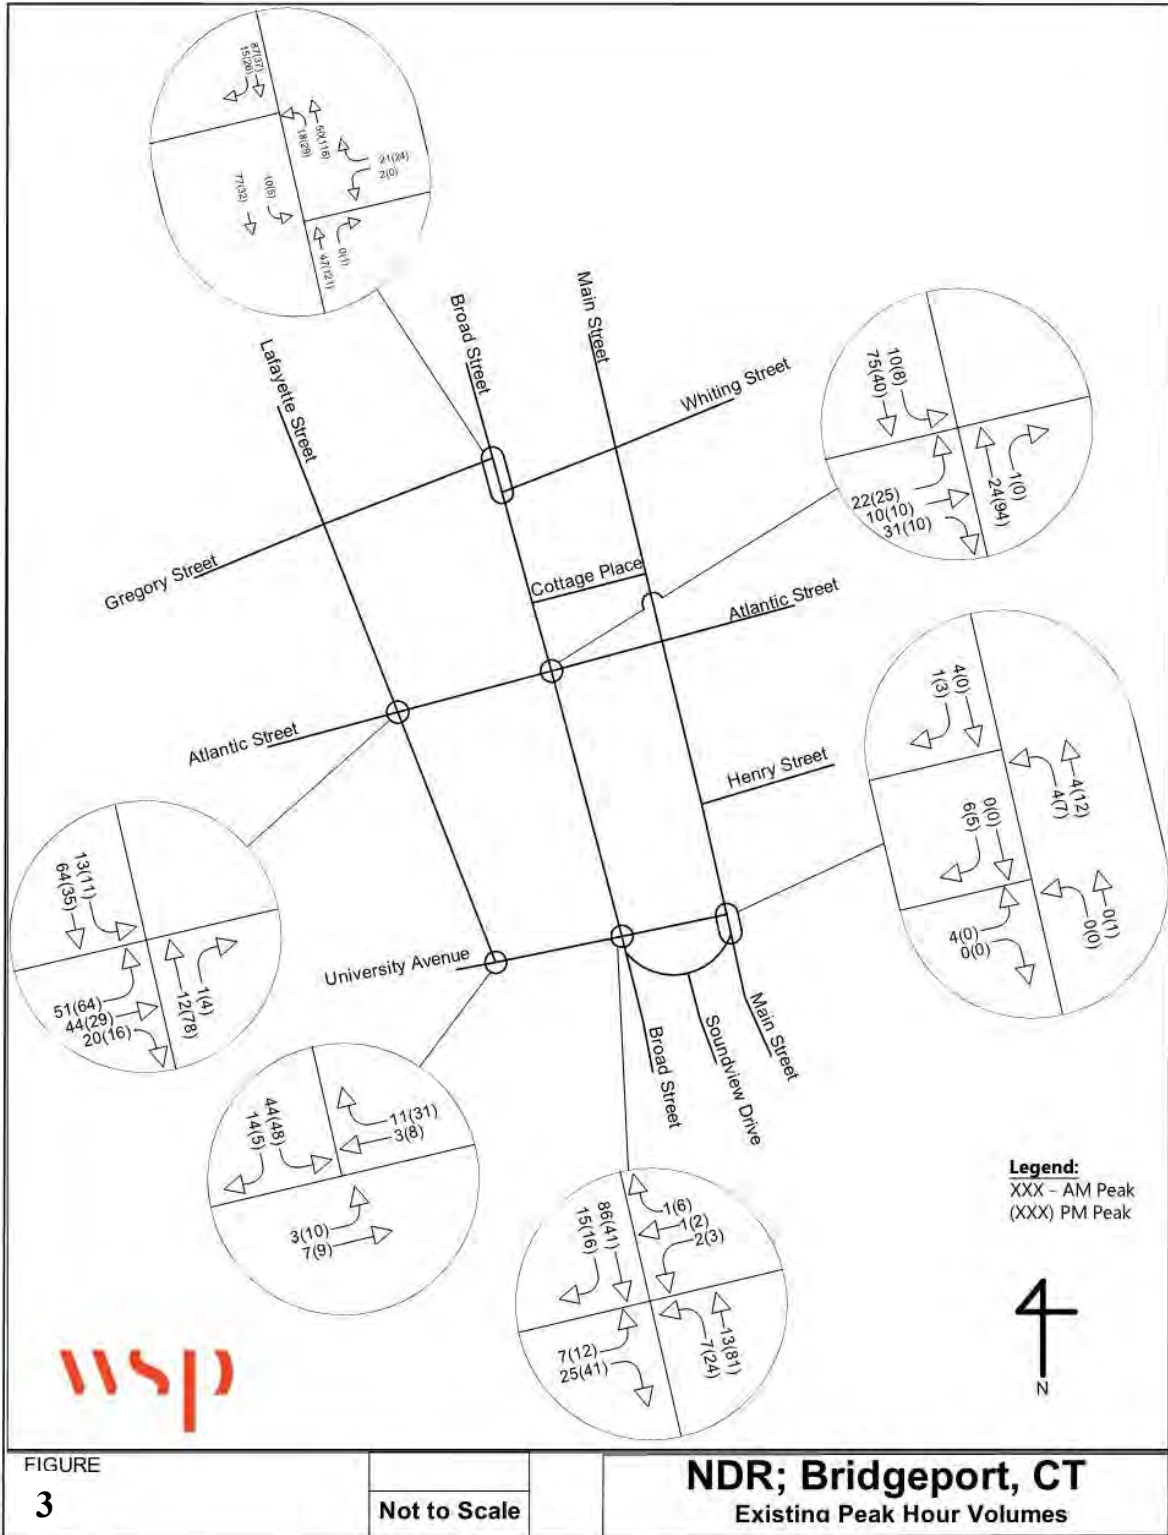
Figure 3 - Existing Conditions - AM and PM Peak Hour Volumes

Intersection turning movement volume, pedestrian, and vehicle classification count data were recorded on December 7, 2017 from 7:00 AM to 9:00 AM (AM Peak Period) and from 4:00 PM to 6:00 PM (PM Peak Period). The count data was performed at the intersections of University Avenue at Lafayette Street, University Avenue at Broad Street, University Avenue at Main Street (including Soundview Circle at Main Street), Atlantic Street at Lafayette Street, Atlantic Street at Broad Street, and Gregory Street (Bishop JC White Boulevard) at Broad Street (including Whiting Street approach). Heavy Vehicle Percentages and Peak Hour Factors (PHFs) were also recorded and calculated at each intersection. The data is included in this report in Appendix A. These volumes and parameters were input into the existing conditions Synchro™ software model (Version 9). The morning and evening peak hour traffic volumes are summarized and illustrated on Figure 3.

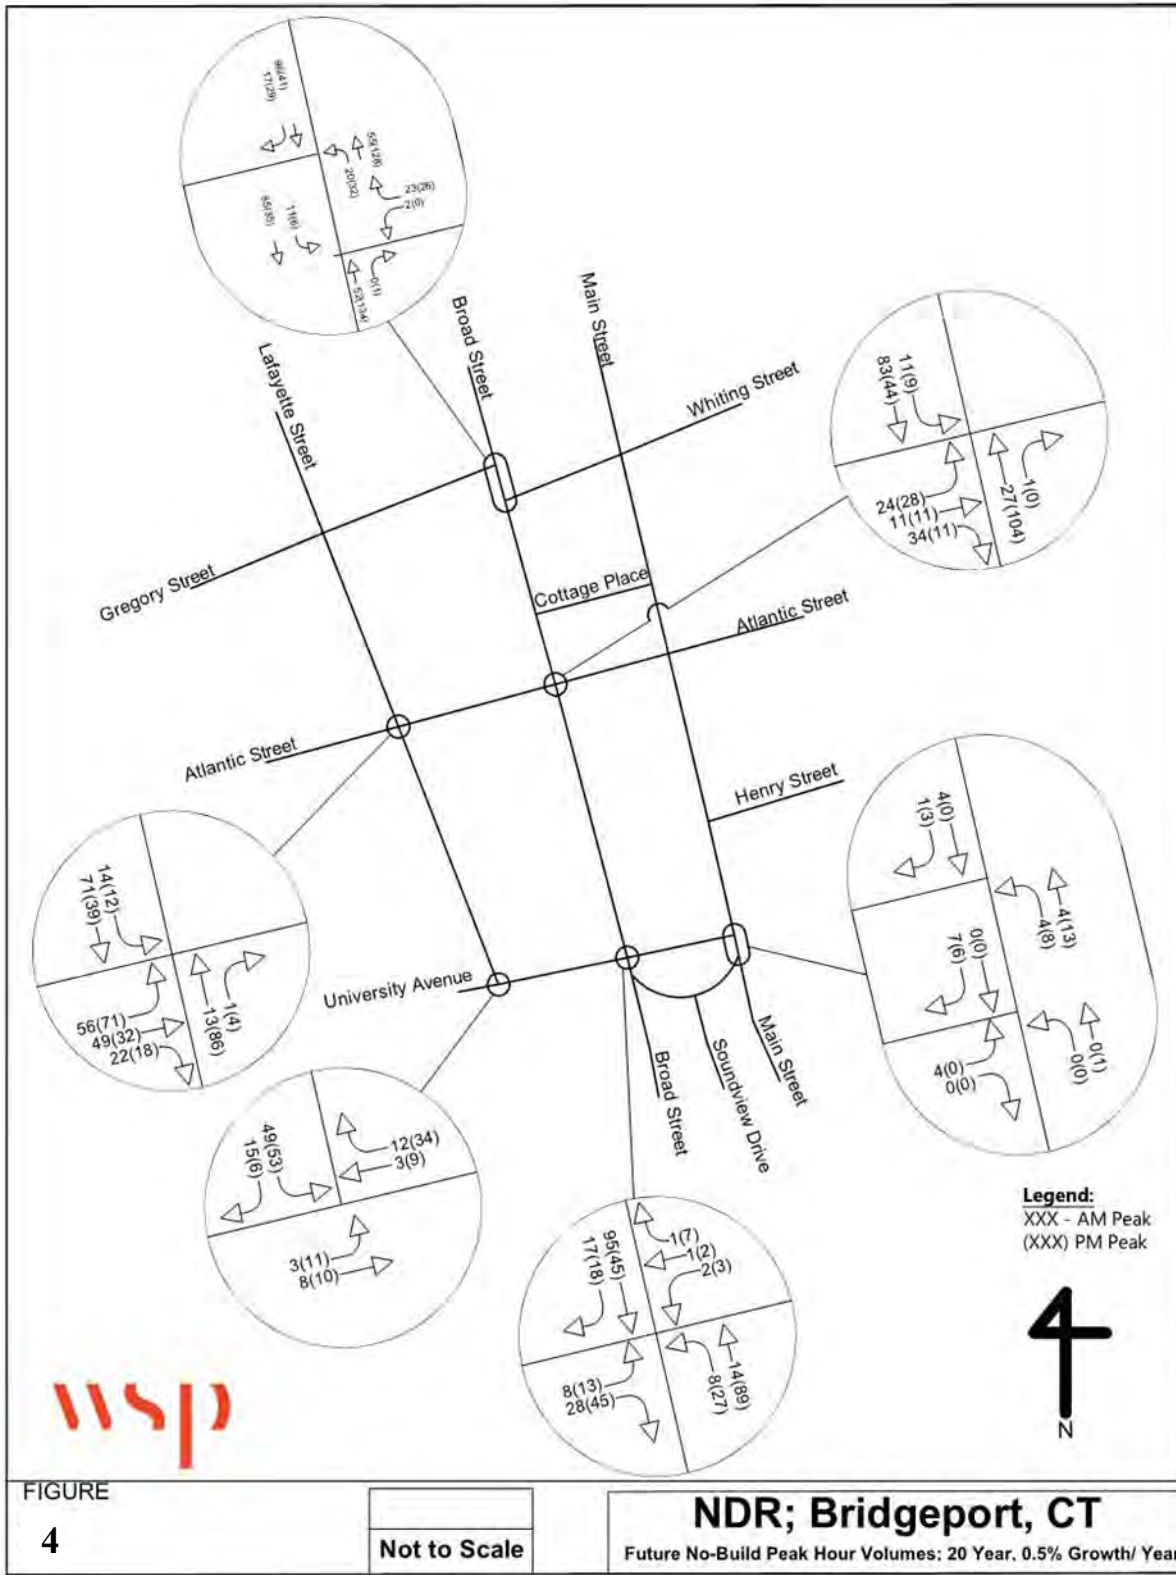
Figure 4 - Future No-Build Conditions - AM and PM Peak Hour Volumes

The CTDOT's Bureau of Policy and Planning was contacted on October 31, 2017 to determine the future growth. Their regional forecasting travel model shows very little growth in the study area and a rate of 0.2 – 0.5 percent growth per year was recommended. These rates do not include any future developments that may occur. To be conservative, this study used the high end, 0.5 percent annual growth rate over 20 years. This resulted in approximately ten (10) percent growth rate over the 20 years to arrive at the 2038 Future No-Build traffic volumes that are provided on Figure 4.

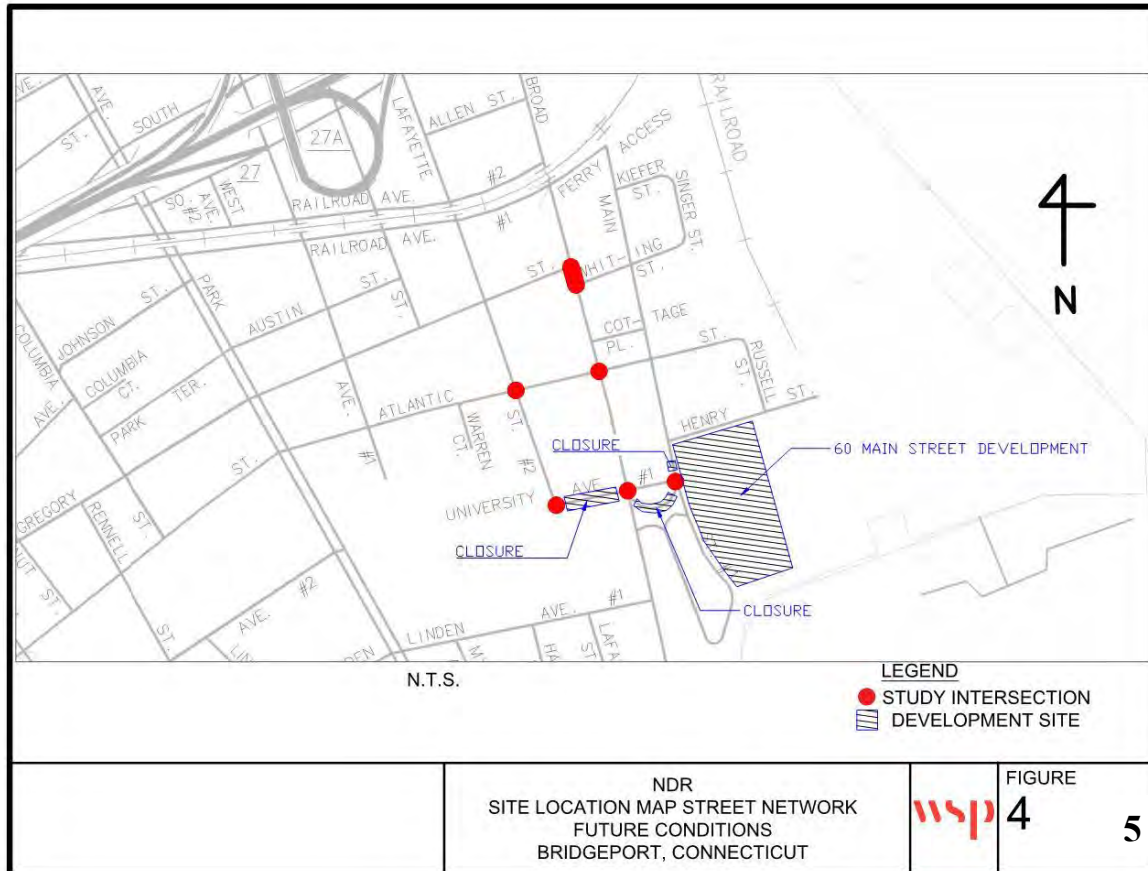
Figure 5 - Proposed Roadway Network - Build Future Condition

- The intersection of Main Street and University Avenue will be an access point to the 60 Main Street development. It will be a two-way, stop controlled entrance/exit;
- North of the intersection of Main Street at University Avenue, there will be an access point to 60 Main Street on Main Street. As described in #4, this entrance will not be accessible from University Avenue; and
- On the south side of Henry Street (a one-way eastbound roadway with access to Main Street) there will be a one-way inlet to 60 Main Street, Broad Street at University Avenue will have stop control on the westbound approach, and Main Street at University Avenue will have stop control on the eastbound and westbound approach.
